# Accessibility Audit Checklist for Built Environment

- **Name of Project / Facility:** Gujarat High Court – Government Complex
- **Location:** Sola, Ahmedabad- 380060, Gujarat
- **Type of Facility:** Institutional Complex
- **Date(s) of Audit performed on site:**
  - Saturday, 20/12/2025 | Sunday, 21/12/25
  - Monday, 19/01/26
- **Date of Audit report generated:**
  - Revision - 00 : March 02, 2026

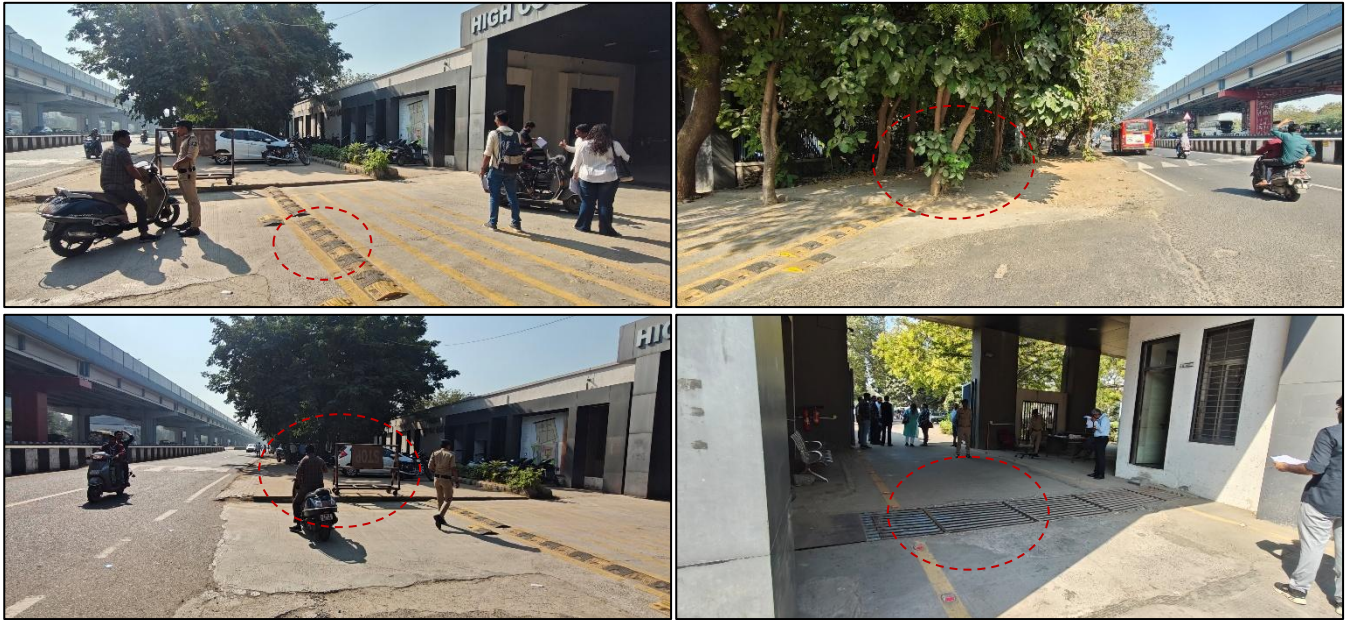
| 1.00 | Site Context & Perimeter Access | | | |
|---|---|---|---|---|
| <p><b>1.1 Approach from Public Road (Gate 5 – Public Entry) :</b><br/> The approach surface generally complies with paving requirements; however, a speed hump near Gate 5 acts as a barrier for wheelchair users and poses difficulty for persons with visual impairment. The cattle-trap (metal pipe grating) at the entrance is a major obstruction and prevents access for wheelchair users, persons with visual impairment, and users of crutches or tricycles.</p> <p><b>1.2 Adjoining Public Footpaths:</b><br/> No usable pedestrian pathway is available on the north side outside Gate 5, making access difficult even for able-bodied pedestrians. On the south side, a paved parking surface is present but is discontinuous and does not provide a connected pedestrian route towards the southern gates.</p> <p><b>1.3 Access from Public Transport:</b><br/> A bus stop is located on the north side; however, there is no safe or continuous pedestrian connectivity to Gate 5 for either able-bodied persons or persons with disabilities. Pedestrians currently use the service road to reach the entrance. A designated drop-off point near the north side of Gate 5 is recommended to facilitate safe transfer for persons with disabilities and other visitors using hired vehicles such as autos or taxis.</p> | | | | |

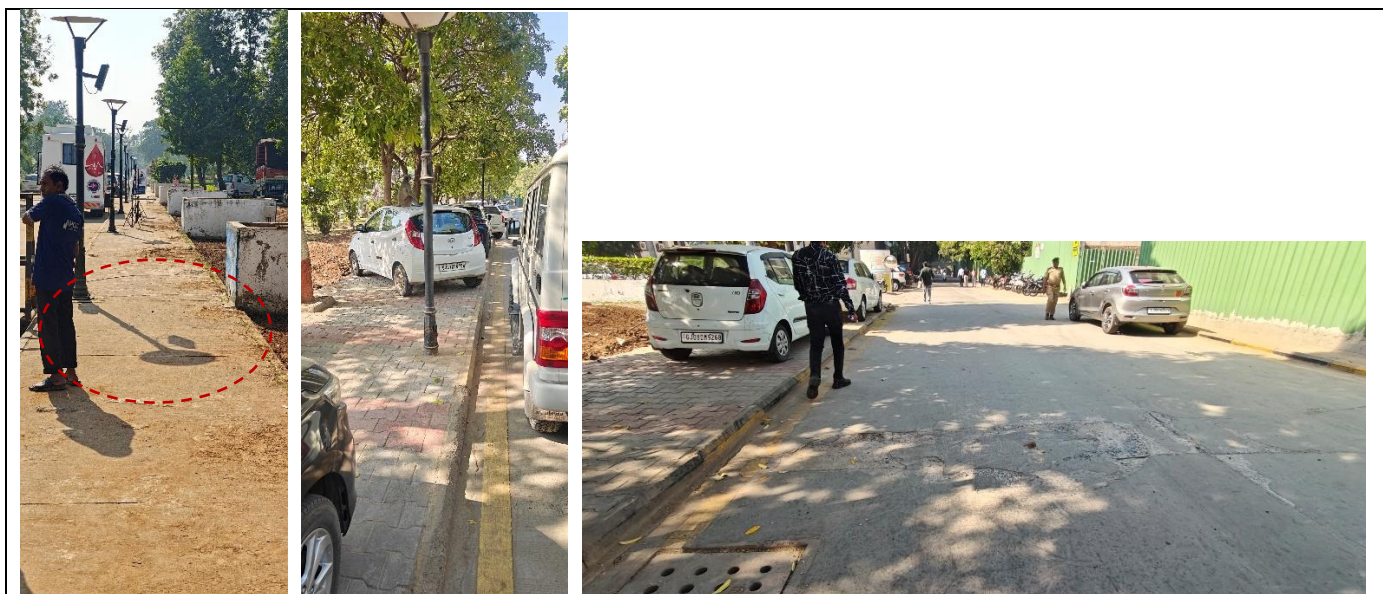
| <p>3.2 Surface Condition: Available walkway surfaces are generally firm and stable; however, level differences (150mm) between the driveway and curb create accessibility barriers. Walkway segments are limited to small patches and discontinue along Administrative Wings A and B.</p> <p>3.3 Cross Slopes: Where present, slopes appear to be within permissible limits.</p> <p>3.4 Width and Edge Protection: Where walkways exist, the clear width is generally more than 900 mm. However, considering two-way pedestrian movement and accessibility requirements, a minimum clear width of 1800 mm is recommended, and that is available on site. Edge protection is not consistently defined. Manholes and stormwater chamber gratings are generally located outside the walkway.</p> | | | | |

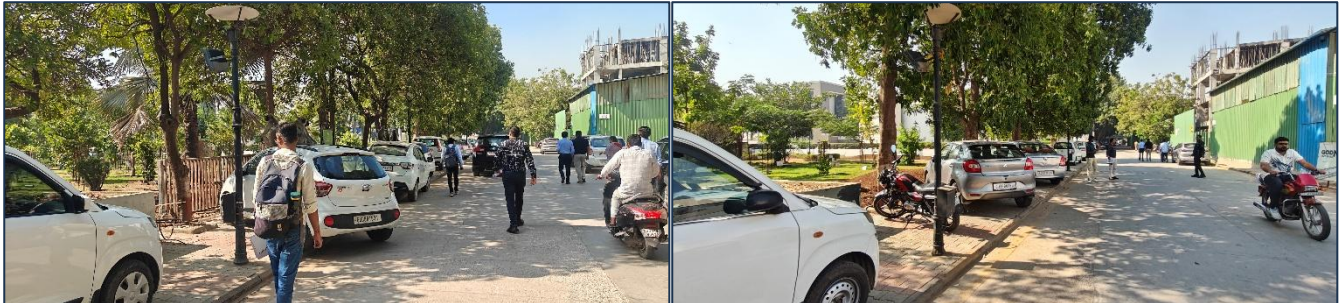
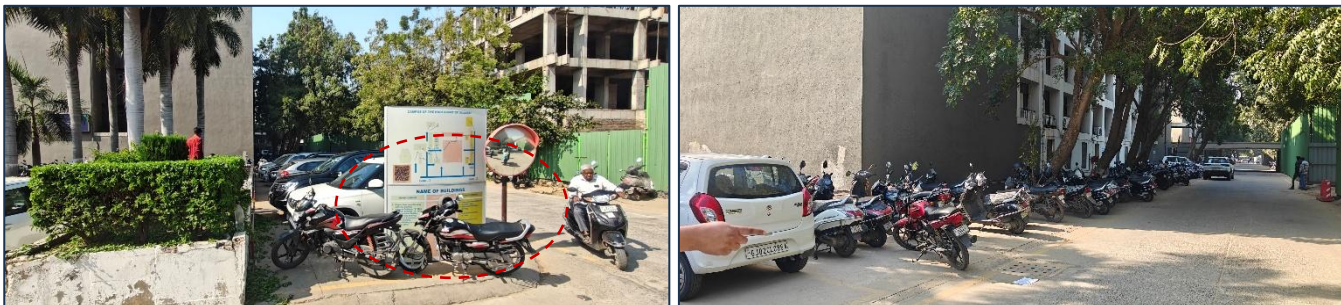
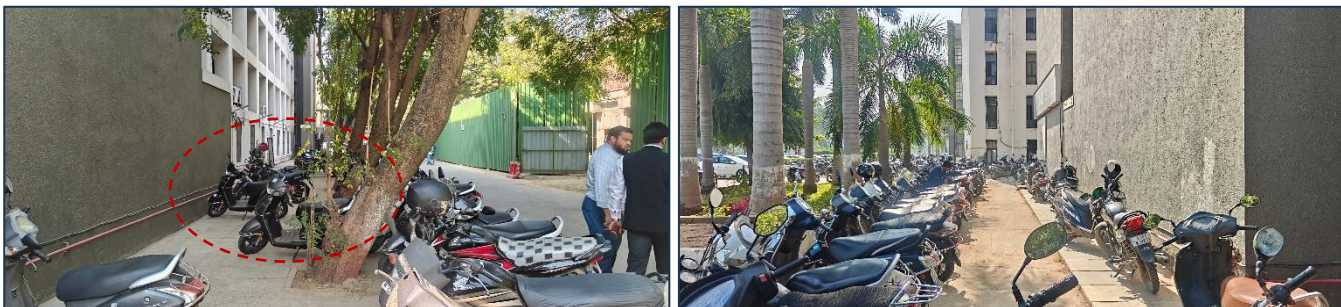
of parking encroachment effectively eliminates safe pedestrian movement and represents one of the most critical accessibility and safety deficiencies observed on the campus.

During the site visit, auditors experienced difficulty moving through the campus and were repeatedly forced to walk along the vehicular driveway due to the absence of usable pedestrian pathways. Pedestrians are required to share space with moving vehicles and are frequently exposed to honking and continuous traffic movement. This creates an unsafe and stressful environment, particularly for persons with disabilities, elderly users, and persons with ambulatory impairments. Even able-bodied pedestrians do not experience a safe or comfortable walking condition under the existing circumstances.

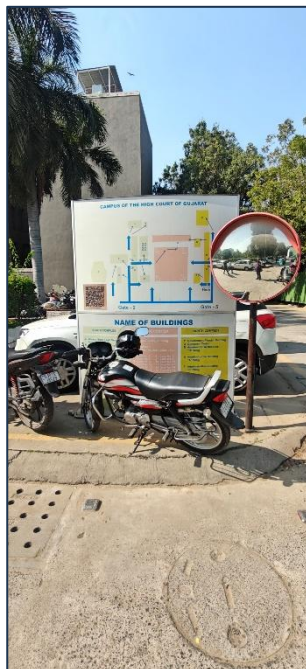
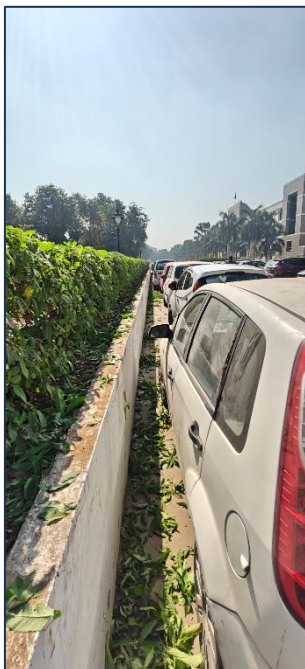
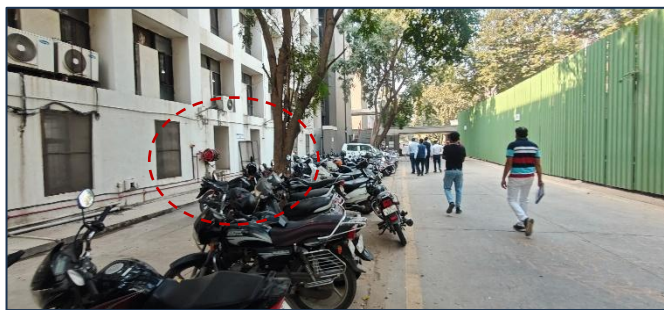
**3.10 Protruding and Obstructing Elements:** The walkway terminates abruptly at the junction between Administrative Building Wing A and the adjacent lawn area, with the paving surface deteriorated at the corner. A streetlight pole obstructs movement at this junction, further reducing usable width. Along Administrative Bldg. Wing A, a large campus signboard (approximately 2 m x 2 m) is installed in the middle of the walkway, creating a major obstruction without providing effective wayfinding value.

Along Administrative Wings A and B, no functional pedestrian walkway exists, as these areas are fully designated and used for vehicle parking. There is no level difference or edge definition between the vehicular driveway and the intended pedestrian zone, and the entire walkway width has effectively been absorbed into two-wheeler and four-wheeler parking. This condition eliminates any safe or identifiable pedestrian route.

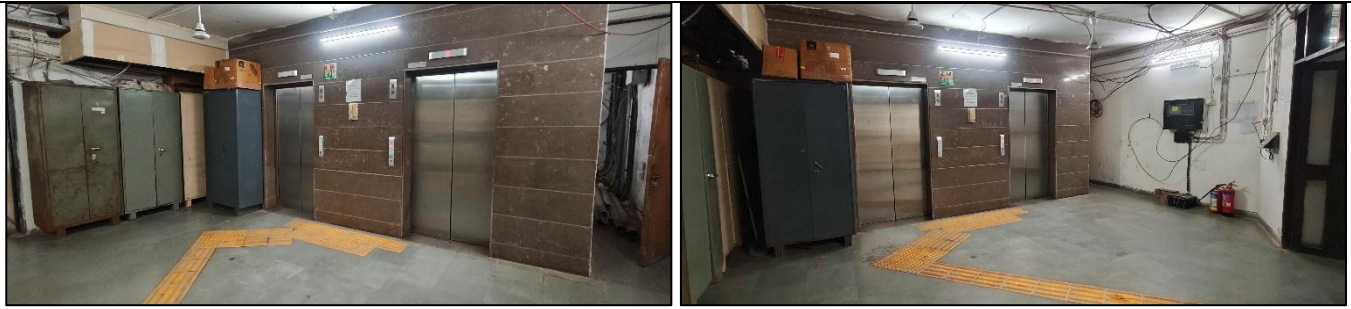
Both lobby areas contain multiple steel storage almirahs, file storage units, and fire extinguishers placed in an unorganized manner, reducing usable circulation space and affecting accessibility. Similar conditions were observed on upper floors.

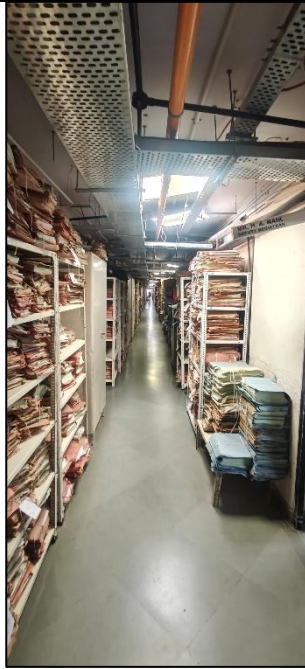
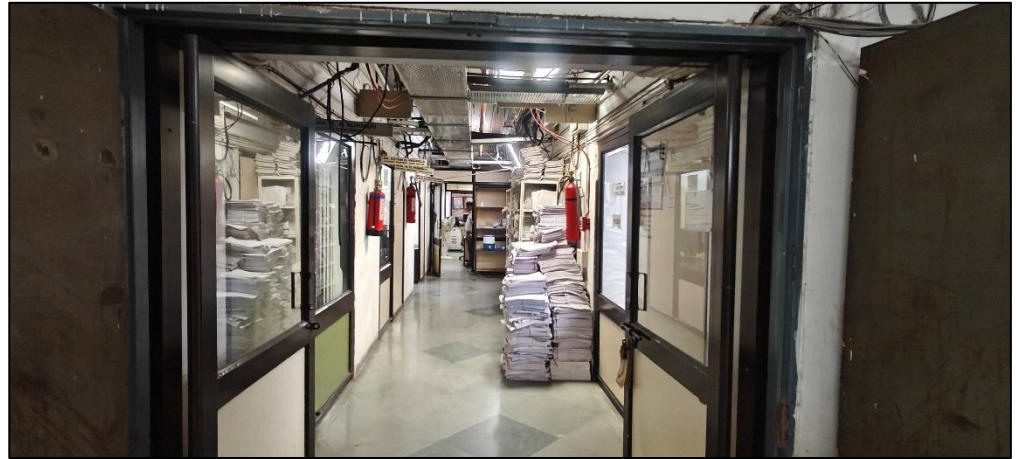
The corridors are heavily loaded with combustible paper files stored on open and unsecured racks along both sides. These materials create continuous obstructions along the primary circulation path, which also serves as the emergency egress route. The storage arrangements reduce usable corridor width and introduce significant hazards.

Emergency egress routes and staircases are not clearly identified through compliant fire exit signage. No continuous visual guidance is provided to indicate the direction of escape routes, location of staircases, or emergency exits. The lack of clear and visible signage significantly affects wayfinding under normal conditions and may critically delay evacuation during emergency situations.

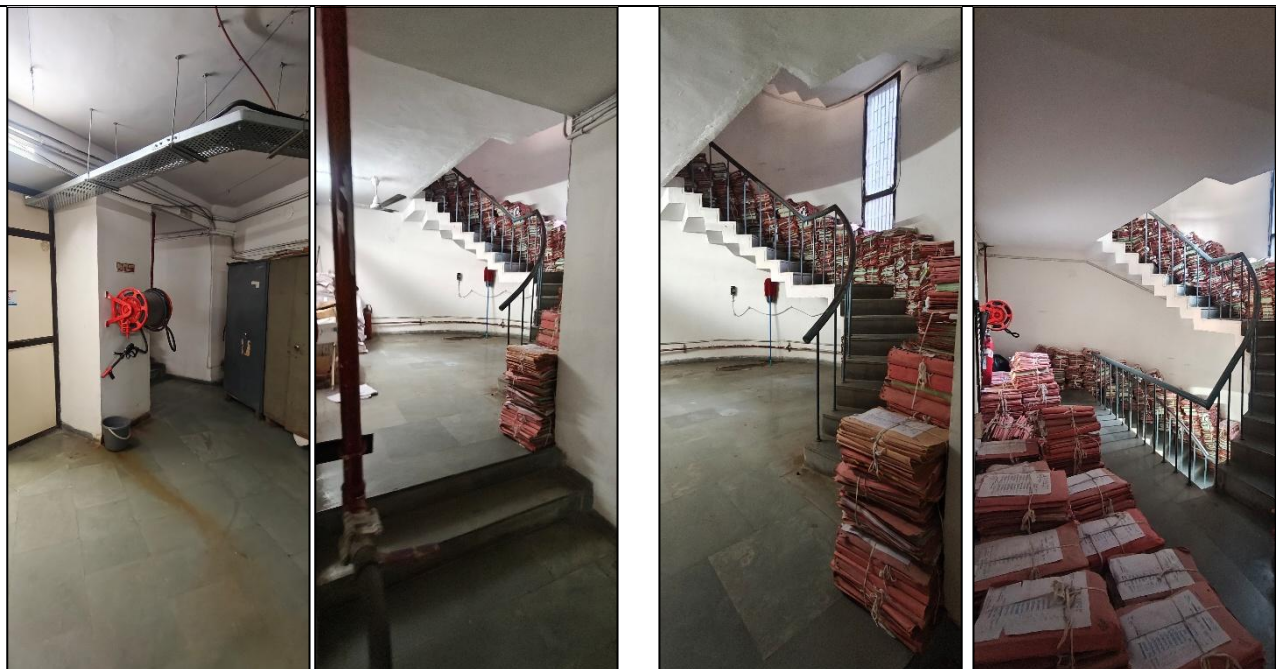
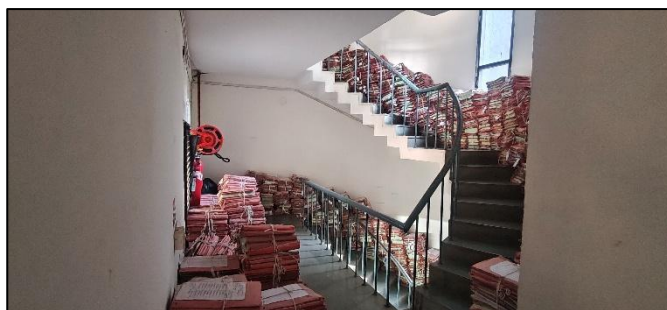
In the event of a fire or emergency, when elevators are non-operational, these staircases would serve as the primary means of evacuation. Given the size of both wings and the expected occupancy load, the present condition represents a serious safety concern. The encroachments, poor lighting, absence of tactile guidance, and non-compliant handrails significantly reduce the effectiveness of these staircases as safe emergency egress routes.

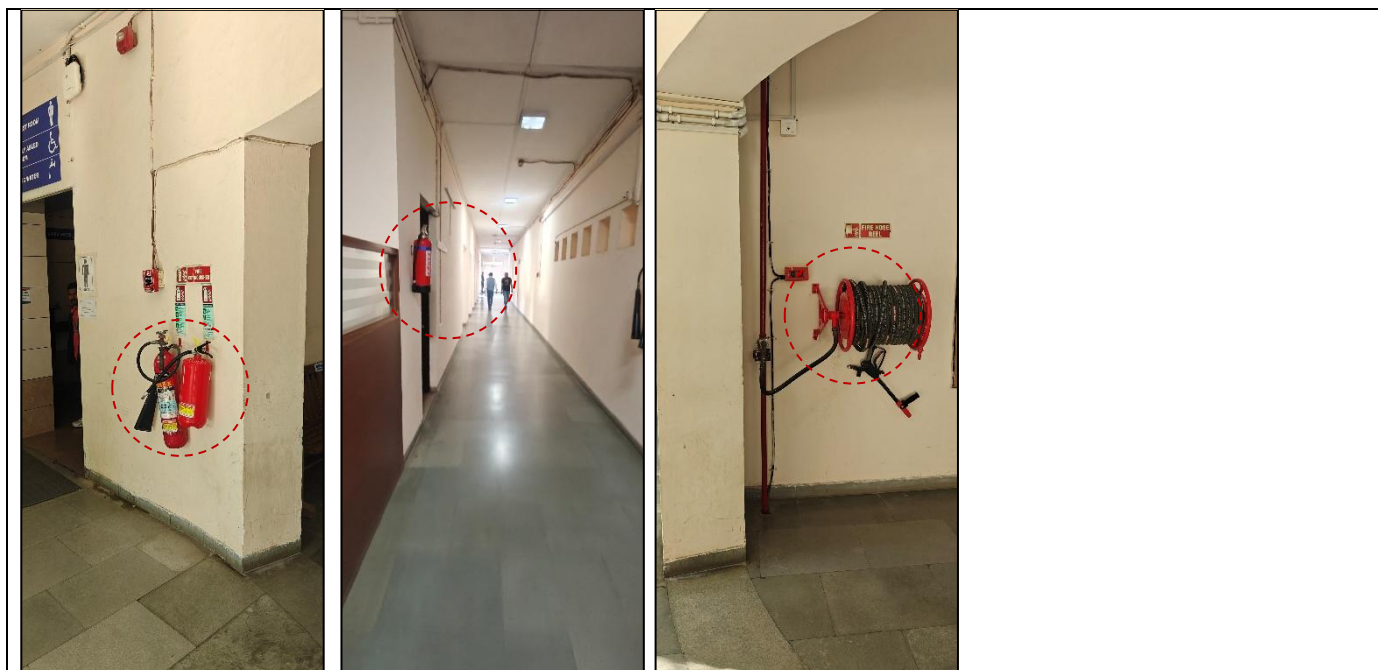
| <p><b>4.1 Corridors and Obstructions:</b><br/>At the ground floor, the peripheral corridors are generally free of obstacles and allow wheelchair accessibility. Minor barriers exist for persons with visual impairment due to fire hydrants mounted along the corridor walls below 2000 mm height. In the lobby areas outside the court chambers at each floor level and in the basement, fire hydrants and fire hose reels are mounted along the walls and project into the circulation space. The hose reels project approximately 400 mm from the wall at a height of about 1200 mm, creating a significant barrier and hazard for persons with visual impairment and low vision.</p> <p><b>Recommendation:</b> At the ground and first floors, this issue can be resolved by relocating fire hydrants into recessed wall niches or to opposite walls where adequate depth is available, so that the equipment remains visible without protruding into the circulation space. Similar treatment is recommended at all floors and basement levels. Fire hose reels should be mounted with a protective frame extending to floor level so that they fall within the cane-detection range, allowing persons with visual impairment and low vision to detect and navigate safely.</p> <p><b>4.2 Corridor Width and Manoeuvring:</b> Corridor widths are sufficient for wheelchair movement. However, improved lighting levels are required, particularly at the ground floor, to support safe movement for persons with low vision.</p> <p><b>4.3 Floor Finish:</b> Floor finishes are firm, even, non-slip, and suitable for mobility aids.</p> <p><b>4.4 Level Changes and Hazard Marking:</b><br/>Minor level projections and changes in level are present along circulation routes. These are not marked with tactile warning blocks or contrasting colour bands. Installation of tactile warning indicators and visual contrast markings is required for persons with visual impairment and low vision.</p> <p><b>Third Floor Bridge:</b><br/>Peripheral corridors are provided at all levels. At the third (top) floor, an arched steel bridge connects the corridors of all four wings and forms part of the internal circulation system.</p> <p>The arched bridge does not comply with accessibility requirements. The gradient exceeds the maximum permissible slope of 1:12 for accessible routes, making it unsuitable for wheelchair users and persons using crutches or other mobility aids. Due to the excessive slope, this connecting route is not accessible to persons with mobility and ambulatory impairments.</p> <p>As a result, continuous accessible connectivity between the four wings at the third-floor level is not achieved. This condition requires corrective intervention to ensure compliance and uninterrupted accessible circulation.</p> | | | | |

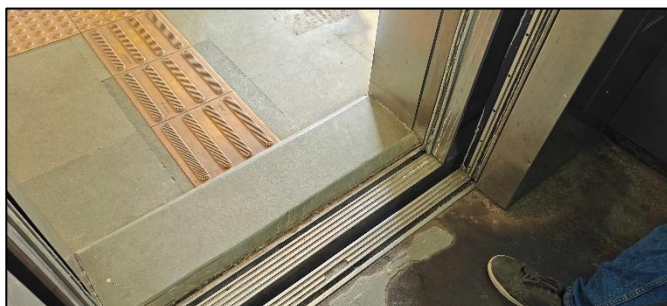
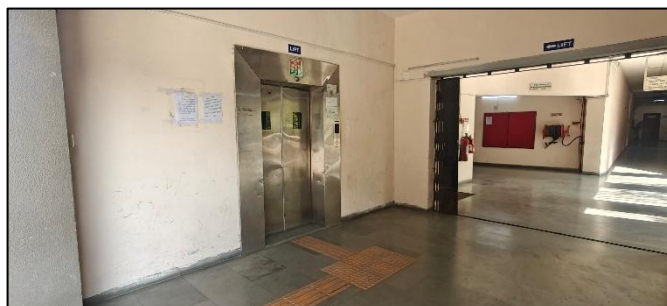
Handrails are missing in some elevator cars and need to be installed or replaced to comply with accessibility requirements. The lift floor surfaces are generally slip-resistant.

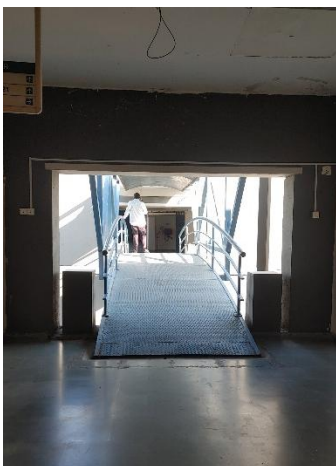
The bridge extends approximately 850 mm onto the floor level, and this level change should be marked with tactile warning tiles for persons with low vision and visual impairment.

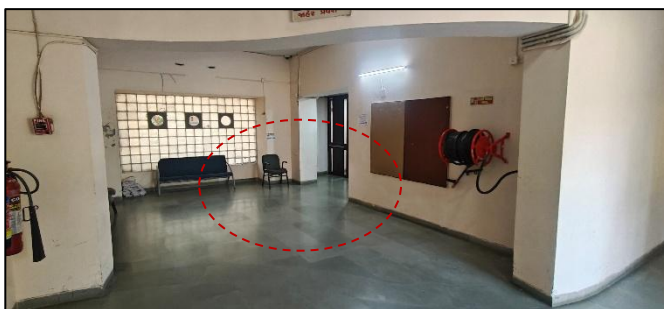
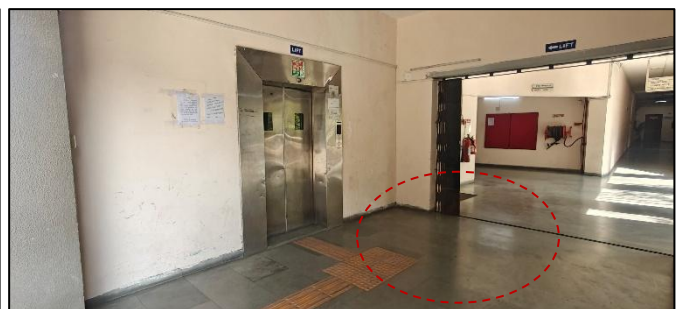
10.4 Tactile Site Maps at Orientation Points: No tactile site maps or orientation maps are provided at major entry points, including the north and south entrances and lobby areas. In a building with multiple wings and long corridors, the absence of tactile orientation maps makes independent navigation difficult for persons with visual impairments. The installation of tactile orientation maps at key entry and decision points is essential to support independent wayfinding and to ensure that tactile guiding paths serve a meaningful navigational function.

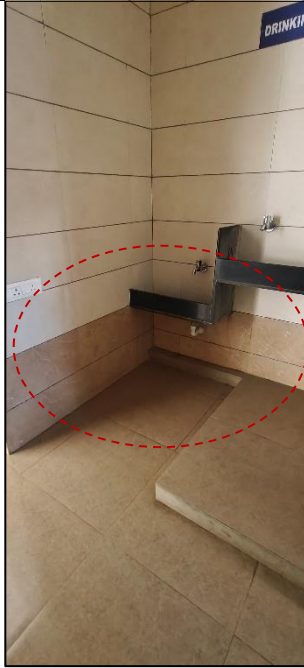
| 12.00 | Restroom Facilities- Dedicated UNISEX FOR PwD | | | |
|---|---|---|---|---|
| <b>Drinking Water Facility:</b><br><br>The drinking water facility consists of wall-mounted taps with custom granite water channels. A 100 mm step-up is provided to access the elevated drinking tap intended for able-bodied users.<br><br>The clear floor space provided (approximately 820 mm wide × 1040 mm long, with 610 mm clearance from floor level) is inadequate for wheelchair manoeuvring and does not provide proper knee and toe clearance as required. The configuration does not comply with HGSUAI-2021 accessibility standards. | | | | |

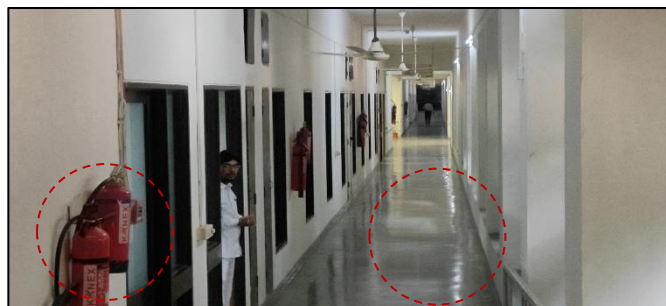
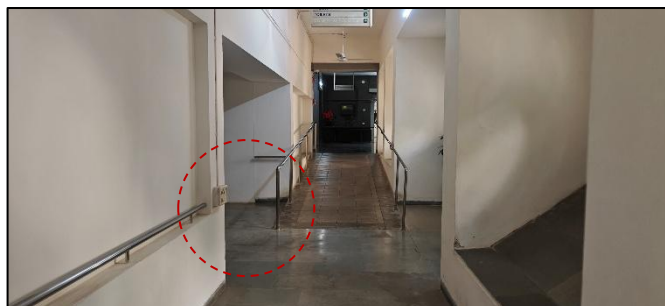
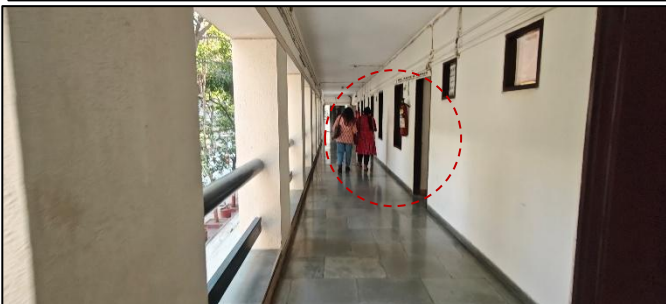
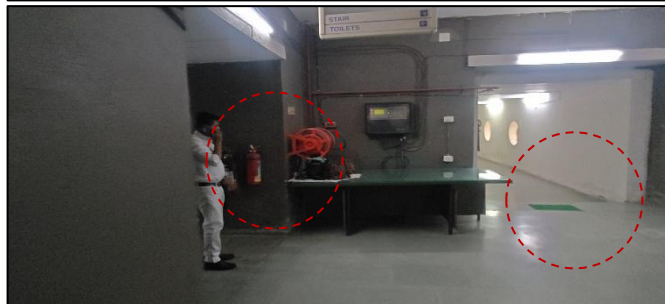
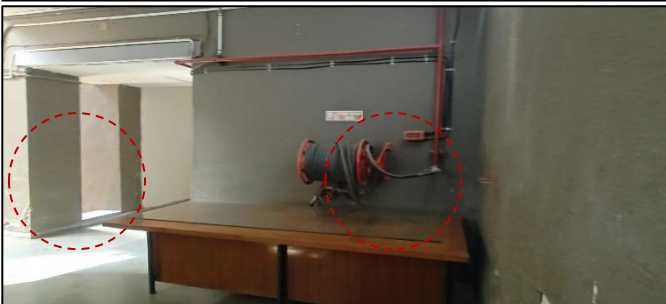
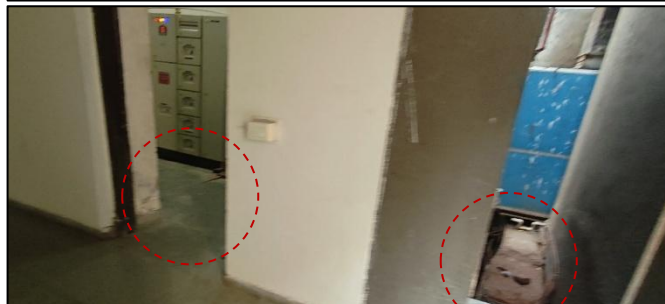
At the south-side lobby, two full-height openings with a 600 mm drop were observed without guardrails. The passage also opens toward the west without defined edge protection. An electrical room was found open and unsecured during simulation. These conditions present serious fall and tripping hazards, particularly for persons with visual impairment and low vision.

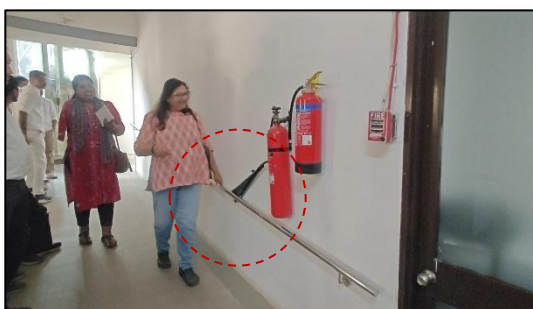
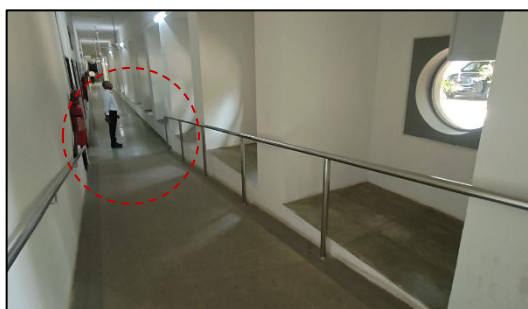
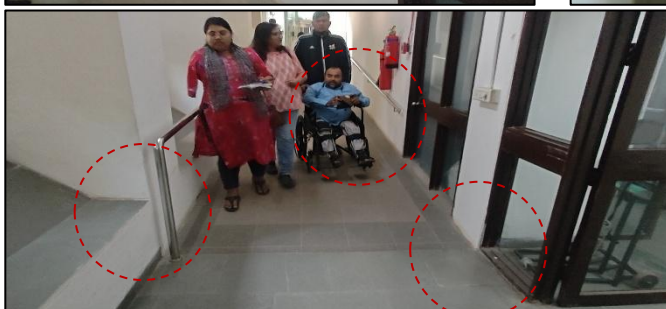
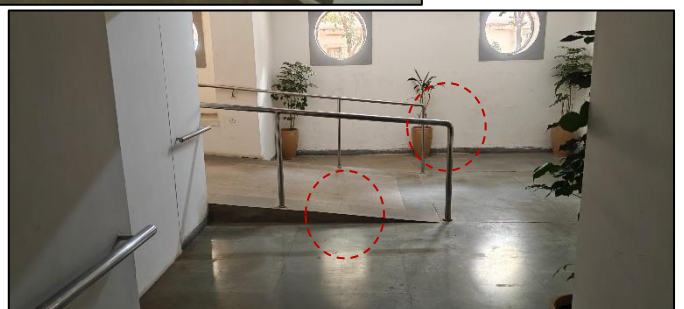
The adjacent steps do not have handrails on both sides. There are no tactile tiles provided for either the steps or the ramp. Tactile warning tiles at both top and bottom of this ramp are also missing.

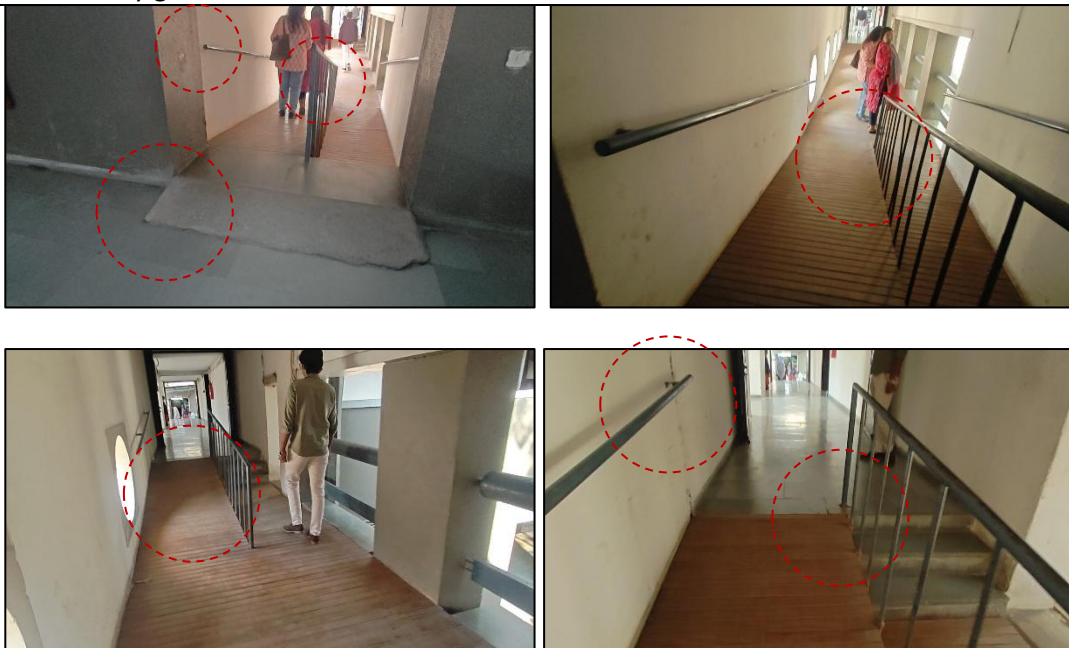
The Computer Centre facility in Block 24 is highly inaccessible in its present condition. The absence of an elevator, non-compliant ramps, non-compliant staircase dimensions, inaccessible restrooms, and lack of tactile and signage provisions collectively result in significant barriers for persons with disabilities, including wheelchair users and persons with ambulatory impairments. Retrofit interventions would be required to achieve compliance with accessibility guidelines.

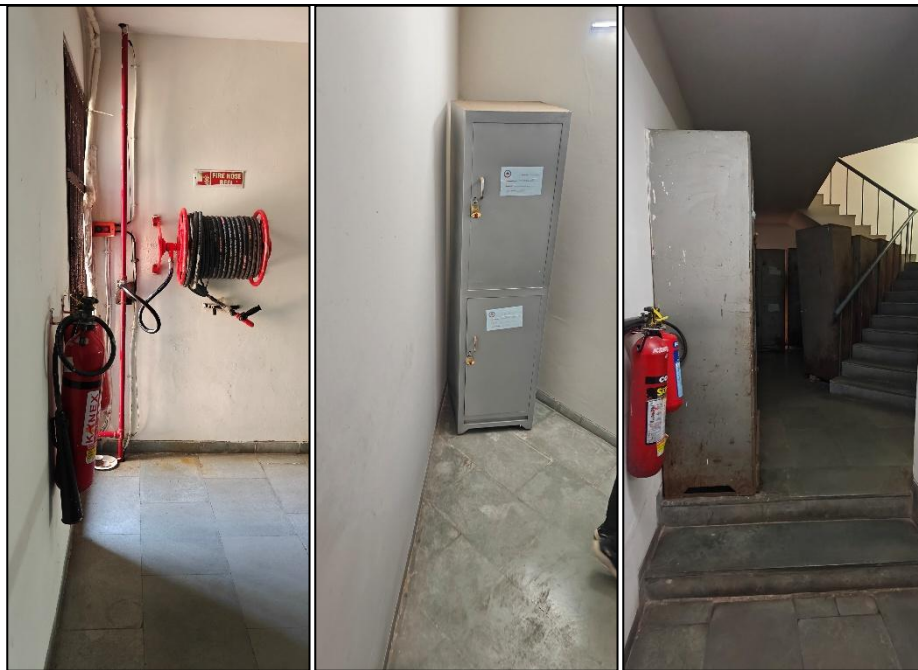
Inadequately placed storage cabinets obstruct access to fire safety equipment, including fire extinguishers and hose reels. These obstructions reduce the required clear space around the equipment and may delay response time during an emergency.

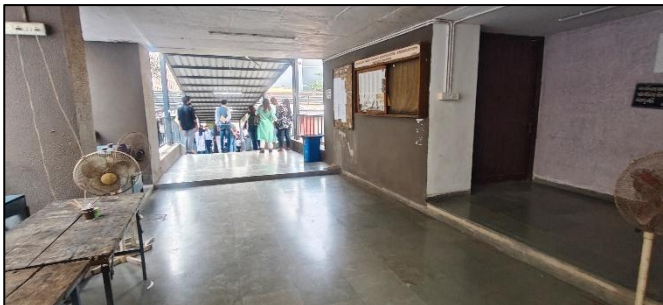
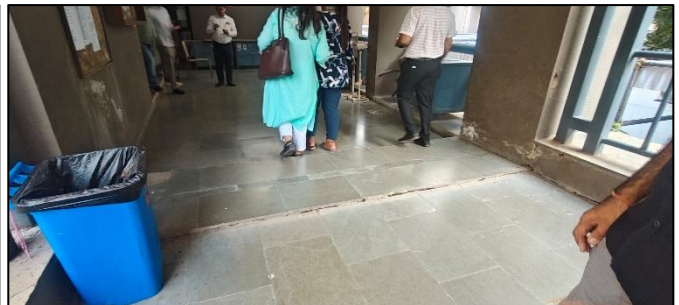
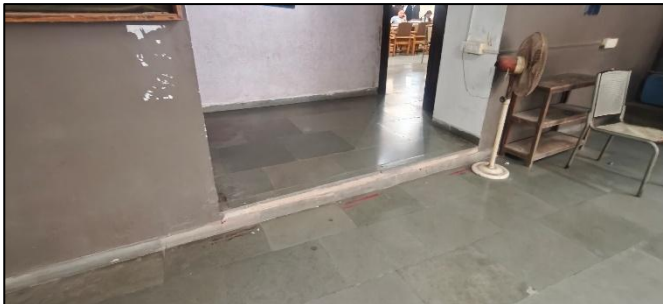
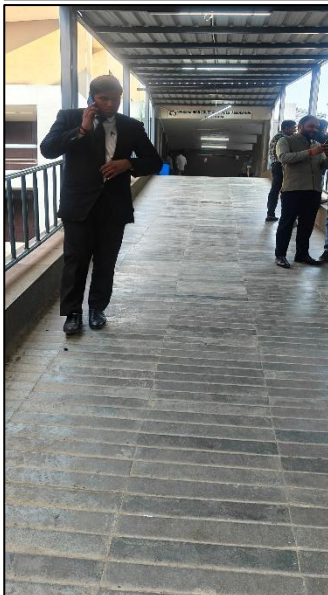
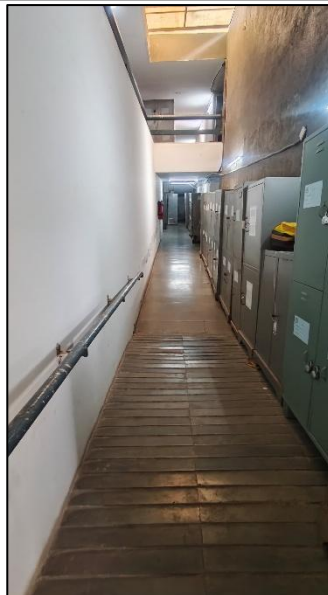
No tactile tiles or guiding indicators are installed along the accessible route. The absence of tactile guidance and warning indicators significantly limits independent navigation for persons with visual impairments. Overall, the building does not provide an accessible environment for persons with visual impairments and requires substantial improvements to meet accessibility standards.

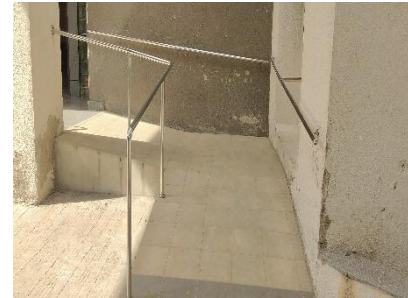
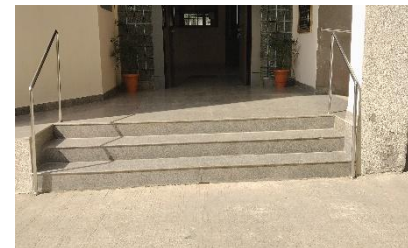
- **Ramp Gradient:** The ramp provided at the entrance has a gradient steeper than the recommended 1:12 ratio, making independent navigation difficult, particularly for wheelchair users and individuals with mobility impairments.
- **Main Entrance:** The entrance door provides adequate clear width; however, the doormat placed at the threshold creates resistance and obstructs smooth wheelchair access.

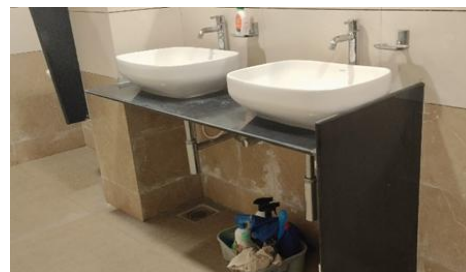
- **Accessible Toilets:**
  - Adequate turning space is available; however, essential accessibility features are missing.
  - Grab bars are not installed.
  - The wash basin height is excessive for users with reduced mobility.
  - The emergency alarm system is non-functional (disconnected wiring observed).
  - The ramp leading to the toilet is slippery, posing a safety hazard.

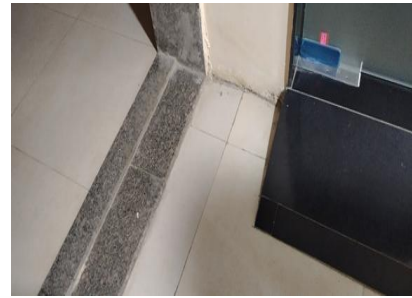
The ramp serving both the toilet and the drinking water station converges at a single point, creating a potentially unsafe and confusing intersection for users with mobility challenges.

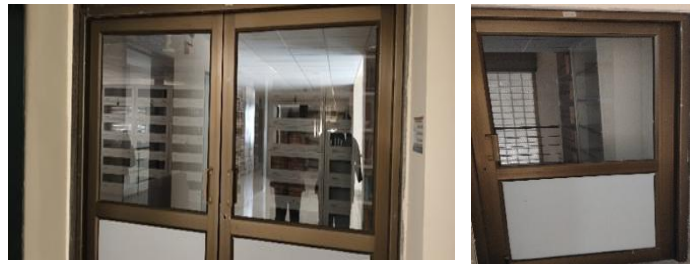
- **Glass Doors:** Extensive use of glass doors causes glare and lacks visual markers, posing risks for individuals with visual impairments.

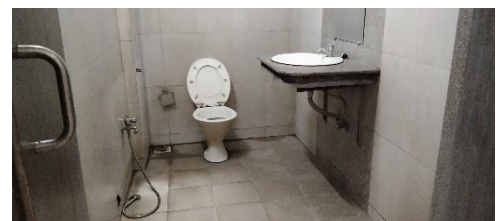
The male and female toilets are spacious; however, multiple level differences make them inaccessible. Redesigning is required to ensure barrier-free access.

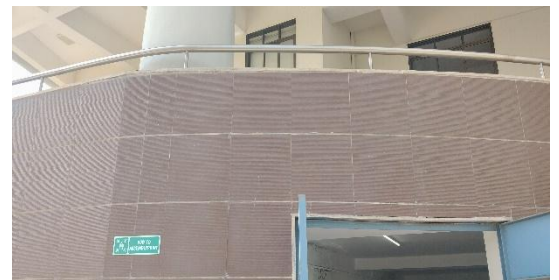
- The building is large; however, there is inadequate signage directing visitors from surrounding roads to the auditorium entrance.
- No clearly defined pathways are provided to guide movement within the building.
