# Accessibility Audit Checklist for Built Environment

- **Name of Project / Facility:** Gujarat High Court – Government Complex
- **Location:** Sola, Ahmedabad- 380060, Gujarat
- **Type of Facility:** Institutional Complex
- **Date(s) of Audit performed on site:**
  - Saturday, 20/12/2025 | Sunday, 21/12/25
  - Monday, 19/01/26
- **Date of Audit report generated:**
  - Revision - 00 : March 02, 2026

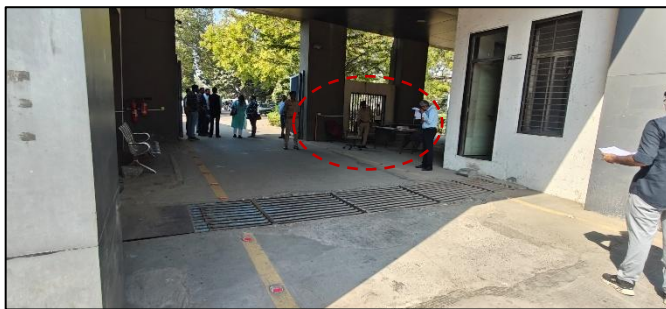
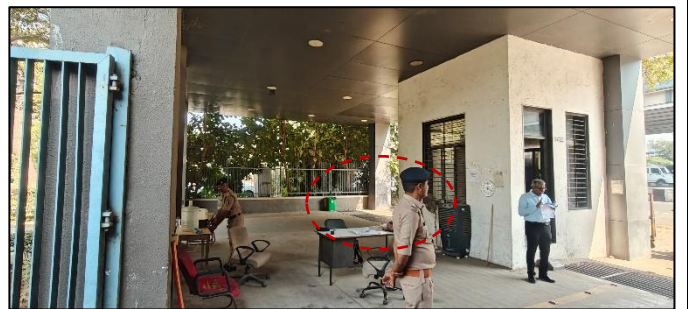
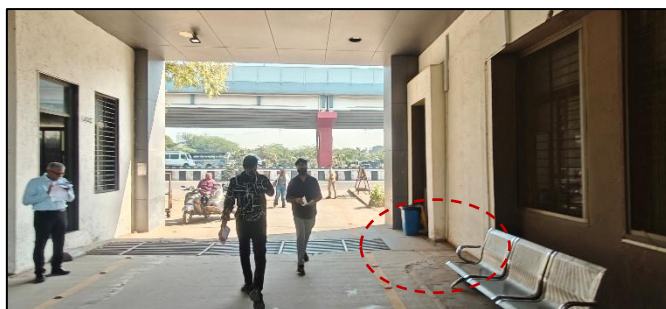
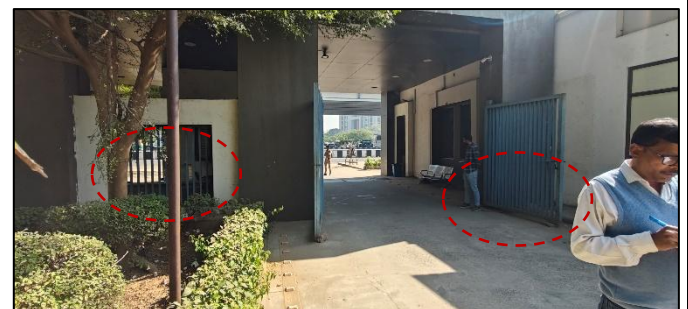
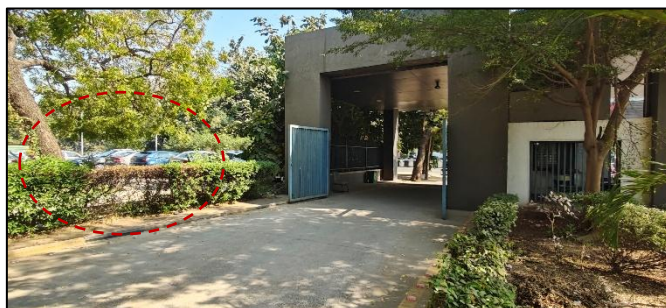
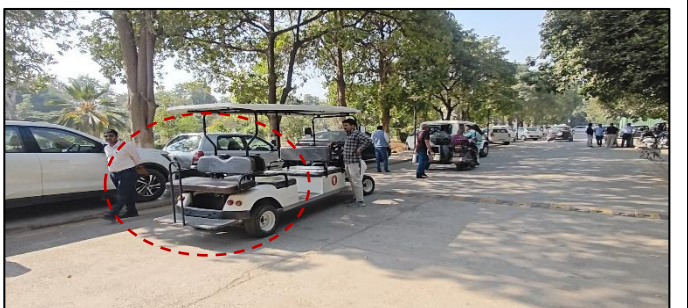
Electric carts should operate on defined routes and should not share the main driveway during peak weekday hours due to heavy vehicular movement. Accessible carts with ramp provision are required to enable use by wheelchair users.

The cart service will benefit a wide range of users with various impairments; however, persons with mobility impairments who rely on wheelchairs require modified carts with wheelchair-accessible entry and ramp provision.

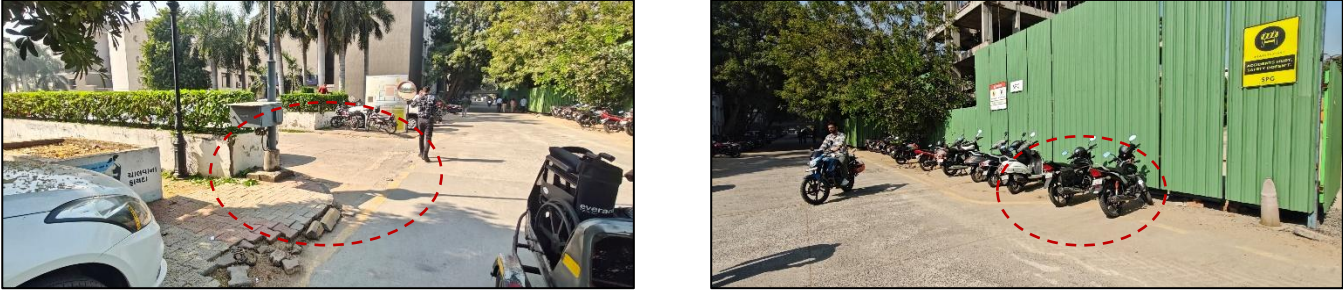
| <p>3.1 Continuous Accessible Route: No continuous step-free accessible route is available from Gate 5 to the Administrative Building (Wings A &amp; B). Existing walkways are fragmented and discontinuous. In fact, designated walkway or walkway at all does not exist along the side of the Administrative Building wings A &amp; B. Walkways do not exist at all towards the other side of the road (north side of the road).</p> | | | | |

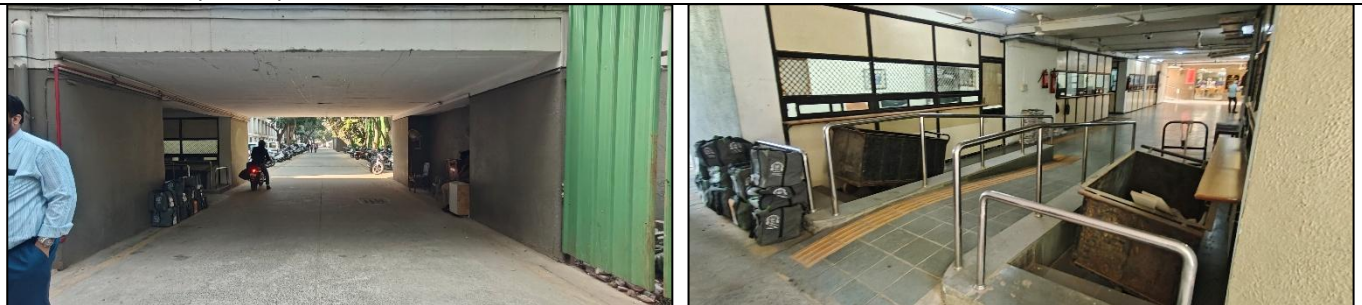
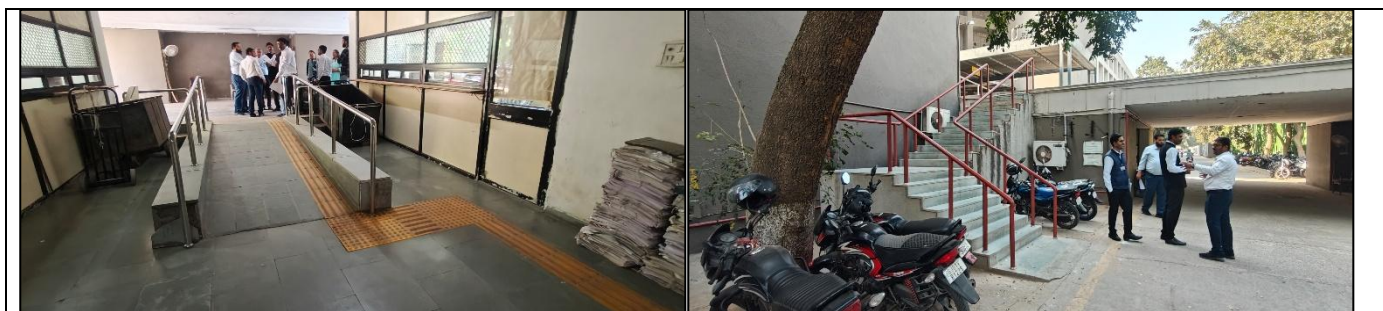
No entrance steps are provided.

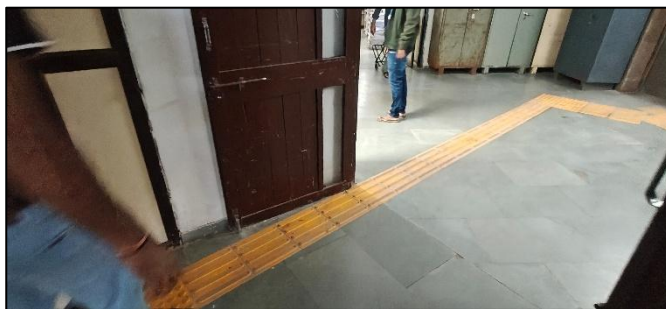
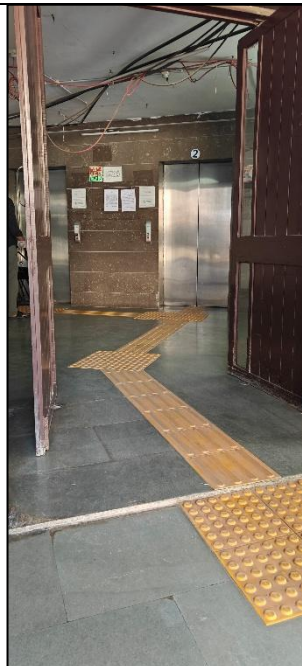
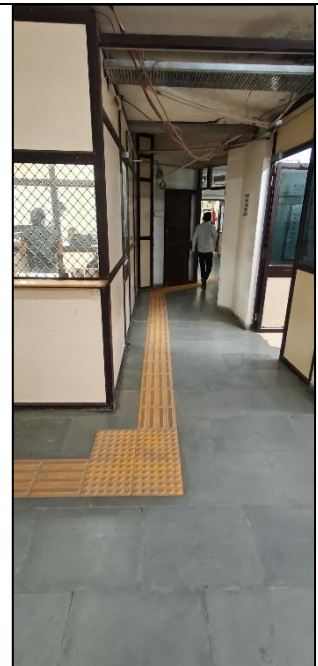
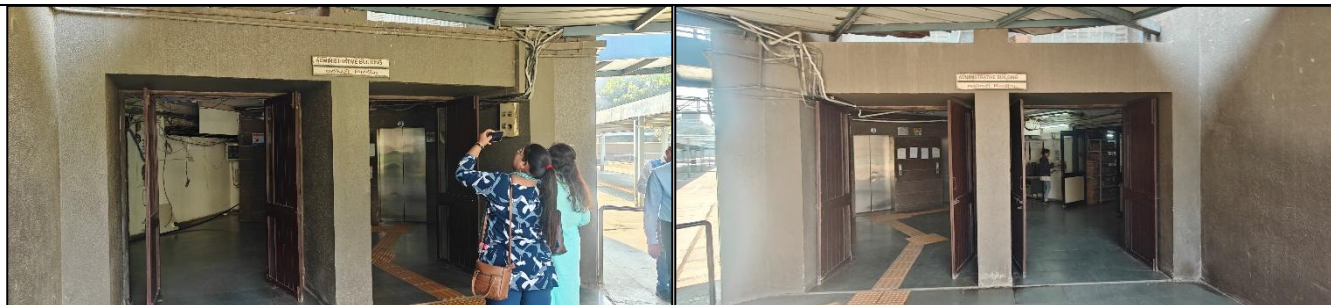
At both ground-floor and first-floor entrances to Wing A and Wing B, the main entry doors consist of double-leaf solid wood shutters with pivoted swing mechanisms. The clear opening width is adequate and exceeds the minimum requirement of 900 mm per accessible leaf. No permanent obstructions were observed reducing the clear opening width. Doors remain open during working hours, allowing unobstructed passage.

At the first-floor entrances to Wings A and B, thresholds of approximately 25 mm (1 inch) are present, which exceed the permissible height of 12 mm and create a barrier to accessibility. No bevelled edge treatment was observed.

Adequate maneuvering space is available on both sides of the doors at ground and first floor levels. Clear floor space requirements for front approach (push and pull sides) appear generally achievable due to the open lobby configuration. No major obstructions were observed at the latch side clearance zones.

Door swings are clear of major circulation routes and do not obstruct accessible movement. Doors typically remain in the open position during working hours, allowing unobstructed circulation.

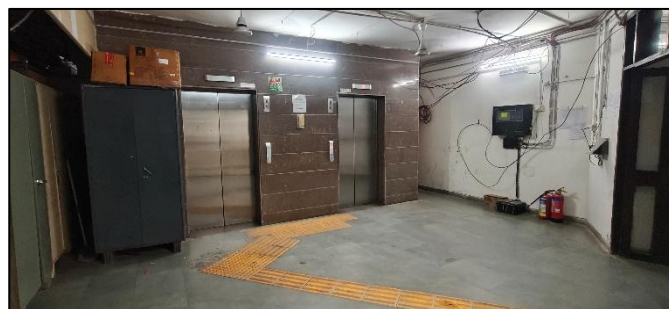
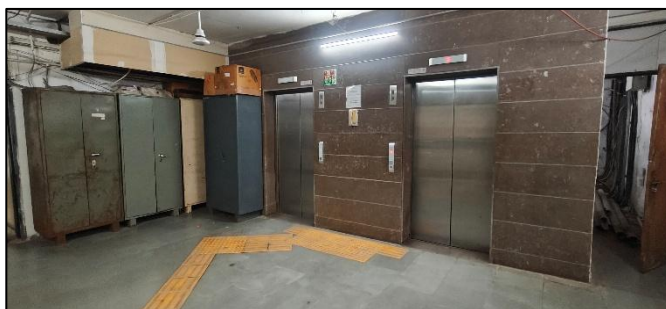
A significant concern is the lack of accessible signage directing users to the elevators. Since elevators represent the only accessible vertical circulation route connecting to the main court building and other functional areas, the absence of clear directional and identification signage makes wayfinding difficult for persons with disabilities and first-time visitors. Properly designed high-contrast, tactile, and clearly visible signage should be installed along major circulation routes to indicate the location of elevators.

**However, the manoeuvring space outside the elevators, particularly at the ground floor, is compromised and often obstructed by storage encroachments, making wheelchair movement and turning difficult and unpredictable.**

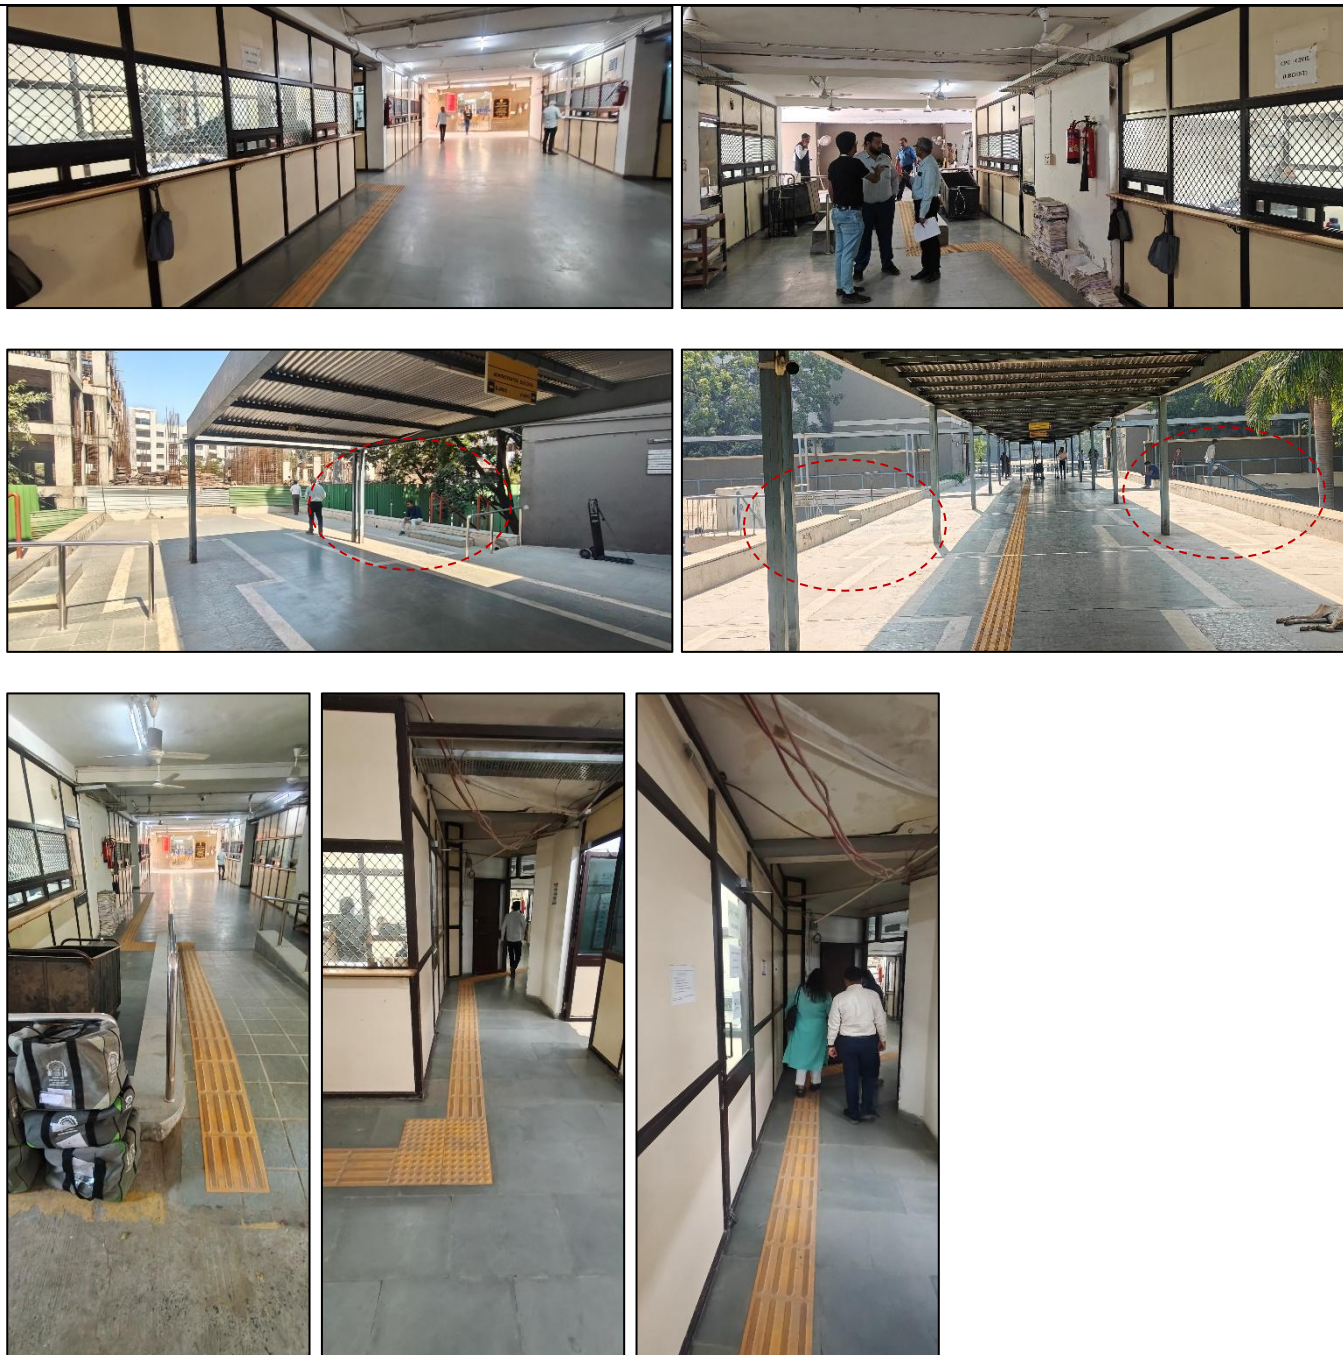
| <p><b>10.1 Tactile Guiding Paths along Primary Routes</b><br/>Tactile guiding paths are partially provided from the main entry ramp and extend into the common access passage serving Wing A and Wing B. However, the guiding path is improperly aligned and runs immediately adjacent to clerk service windows and standing areas, resulting in a conflict with required clear movement and manoeuvring space. This placement reduces usability and may cause obstruction for both wheelchair users and persons with visual impairments.</p> <p>The tactile guiding path does not extend to essential destinations, including the staircases, elevator lobbies, toilet blocks, or the main internal corridors of Wing A and Wing B. As a result, the guiding path does not function as a continuous accessible navigation system and therefore does not comply with accessibility standards.</p> <p><b>10.2 Compliance of Tactile Guiding Paths</b><br/>The existing tactile guiding paths do not fully comply with code requirements, as they lack logical routing and continuity between major functional spaces. For persons with visual impairments, tactile paths must connect all key destinations in a clear and predictable sequence.</p> <p>Additionally, tactile guiding paths require supporting orientation aids such as tactile maps or information panels. Without these orientation tools, the tactile path functions only as a linear track without providing meaningful information about direction or destination, limiting its practical usability.</p> <p><b>10.3 Tactile Warning Blocks at Hazards and Level Changes</b><br/>No tactile warning blocks are provided at the top and bottom landings of staircases, including the steps leading to staircase approaches. The absence of warning indicators presents a significant safety risk for persons with visual impairments.</p> <p>Similarly, no tactile warning blocks are provided at ramp transitions or other level changes.</p> <p>At the first-floor common corridor of Wing A and Wing B, low-height railings are present without associated tactile warning blocks. This condition creates a potential hazard for persons with visual impairments, as the railing edges and adjacent level differences are not detectable through tactile cues.</p> <p>Overall, the provision of tactile warning indicators is inadequate and does not comply with accessibility standards.</p> <p><b>10.4 Tactile Site Maps at Orientation Points</b><br/>No tactile site maps or orientation maps are provided at major entry points, including the main entrance or lobby areas. The absence of tactile maps makes independent navigation difficult for persons with visual impairments, particularly in a complex building where multiple wings and circulation routes intersect.</p> <p>The installation of tactile orientation maps at key entry and decision points is strongly recommended to support independent wayfinding and to ensure that tactile guiding paths serve a meaningful navigational function.</p> | | | | |

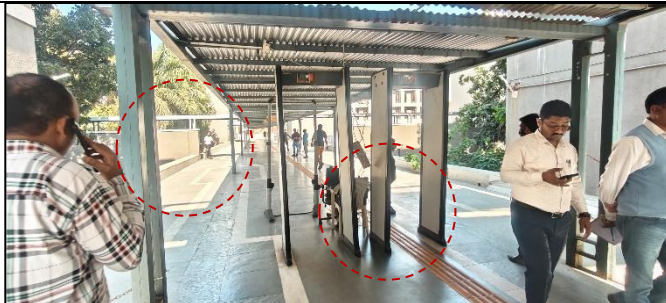
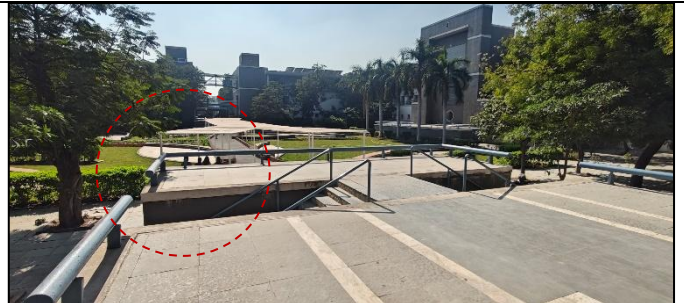
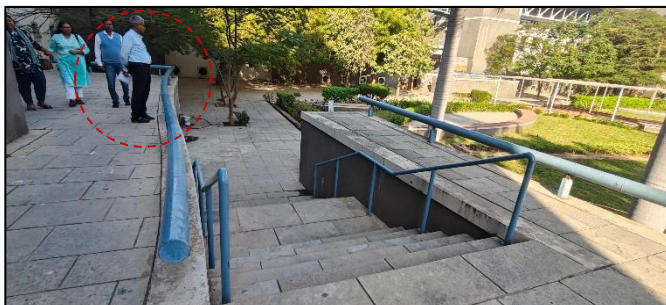
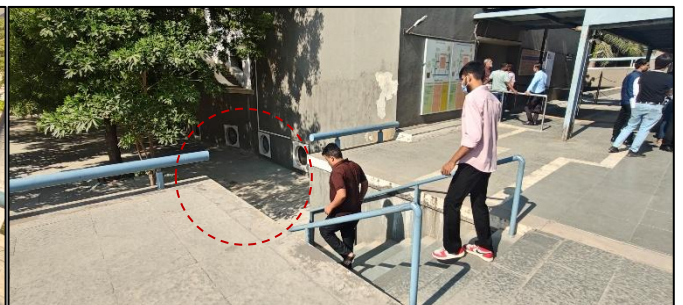
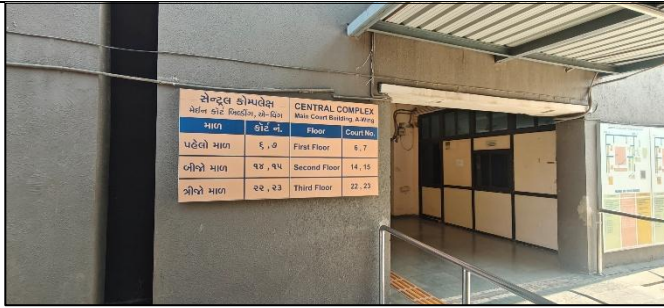
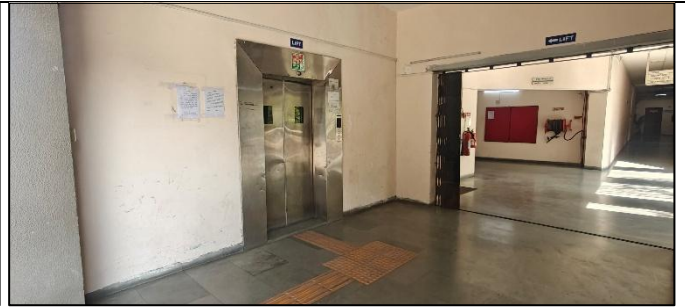
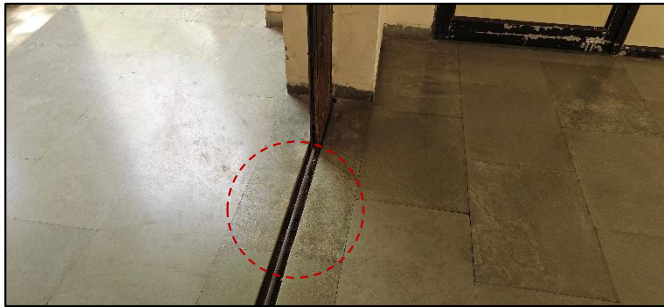
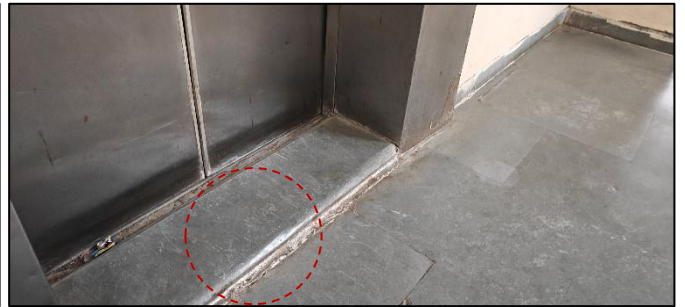
Access to the ground floor courts is primarily dependent on elevators at the main entry, while internal staircase access requires additional travel distances. This creates a serious limitation for accessible entry and emergency evacuation, particularly considering the building occupancy and functional importance.

**Potential Accessibility Improvement:** There may be a possibility to explore a continuous accessible route from the east side of the main courthouse building, where entry could be provided directly at the ground floor level. This could help resolve the accessibility limitations at the main court building, as the ground floor is connected to the elevators, providing access to the upper floors. However, security issues and possible flexibility with structure need to be analysed and explored to check the viability of this proposal.

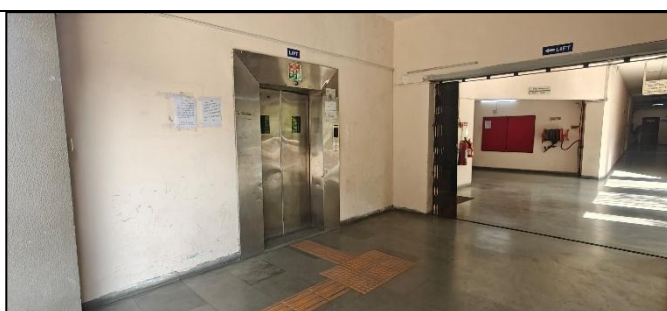
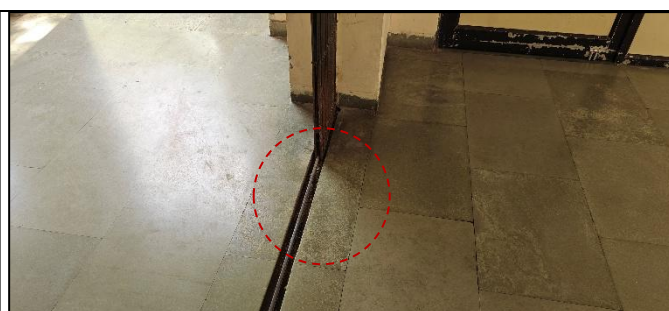
2.5 Visual Markings: Not applicable, as glazed doors are not provided.

2.6 Door Swing: Not applicable, as the collapsible grills remain open and do not obstruct circulation paths.

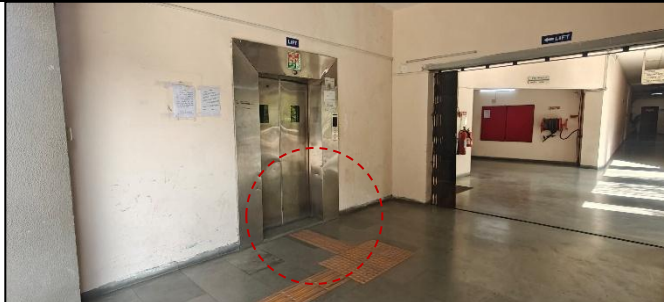
3.4 Flooring: Flooring is firm, even, and non-slip, and generally suitable for mobility aids.

3.5 Low Vision Usability: Persons with low vision may experience difficulty navigating the lobby areas due to the lack of visual contrast between floors, walls, and architectural elements. Contrast marking at door transitions, elevator frames, and wall skirtings would significantly improve spatial legibility with minimal intervention.

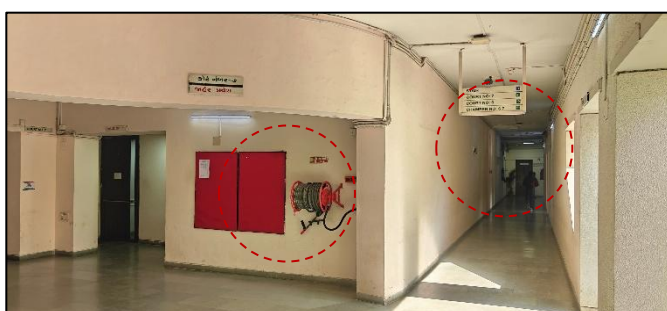
| <p><b>4.1 Corridors and Obstructions:</b><br/>At the ground floor, the peripheral corridors are generally free of obstacles and allow wheelchair accessibility. Minor barriers exist for persons with visual impairment due to fire hydrants mounted along the corridor walls below 2000 mm height. In the lobby areas outside the court chambers at each floor level and in the basement, fire hydrants and fire hose reels are mounted along the walls and project into the circulation space. The hose reels project approximately 400 mm from the wall at a height of about 1200 mm, creating a significant barrier and hazard for persons with visual impairment and low vision.</p> <p><b>Recommendation:</b> At the ground and first floors, this issue can be resolved by relocating fire hydrants into recessed wall niches or to opposite walls where adequate depth is available, so that the equipment remains visible without protruding into the circulation space. Similar treatment is recommended at all floors and basement levels. Fire hose reels should be mounted with a protective frame extending to floor level so that they fall within the cane-detection range, allowing persons with visual impairment and low vision to detect and navigate safely.</p> <p><b>4.2 Corridor Width and Manoeuvring:</b> Corridor widths are sufficient for wheelchair movement. However, improved lighting levels are required, particularly at the ground floor, to support safe movement for persons with low vision.</p> <p><b>4.3 Floor Finish:</b> Floor finishes are firm, even, non-slip, and suitable for mobility aids.</p> <p><b>4.4 Level Changes and Hazard Marking:</b><br/>Minor level projections and changes in level are present along circulation routes. These are not marked with tactile warning blocks or contrasting colour bands. Installation of tactile warning indicators and visual contrast markings is required for persons with visual impairment and low vision.</p> <p><b>Third Floor Bridge:</b><br/>Peripheral corridors are provided at all levels. At the third (top) floor, an arched steel bridge connects the corridors of all four wings and forms part of the internal circulation system.</p> <p>The arched bridge does not comply with accessibility requirements. The gradient exceeds the maximum permissible slope of 1:12 for accessible routes, making it unsuitable for wheelchair users and persons using crutches or other mobility aids. Due to the excessive slope, this connecting route is not accessible to persons with mobility and ambulatory impairments.</p> <p>As a result, continuous accessible connectivity between the four wings at the third-floor level is not achieved. This condition requires corrective intervention to ensure compliance and uninterrupted accessible circulation.</p> | | | | |

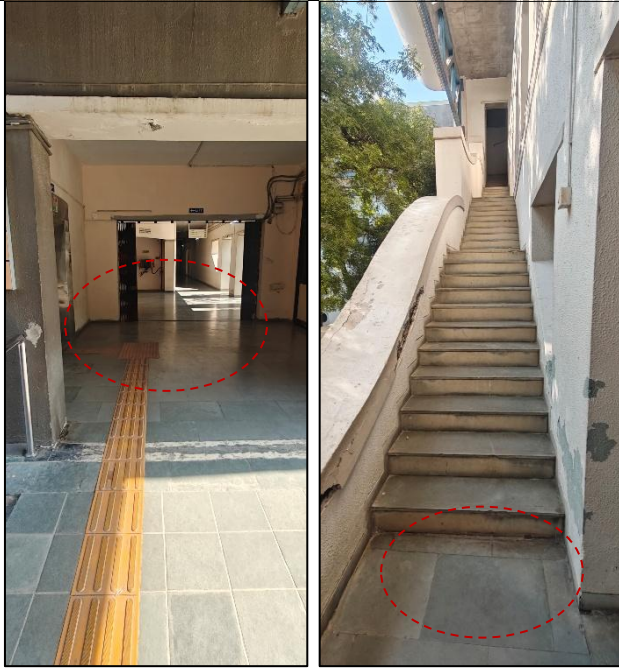
10.4 Tactile Site Maps at Orientation Points: No tactile site maps or orientation maps are provided at major entry points, including the north and south entrances and lobby areas. In a building with multiple wings and long corridors, the absence of tactile orientation maps makes independent navigation difficult for persons with visual impairments. The installation of tactile orientation maps at key entry and decision points is essential to support independent wayfinding and to ensure that tactile guiding paths serve a meaningful navigational function.

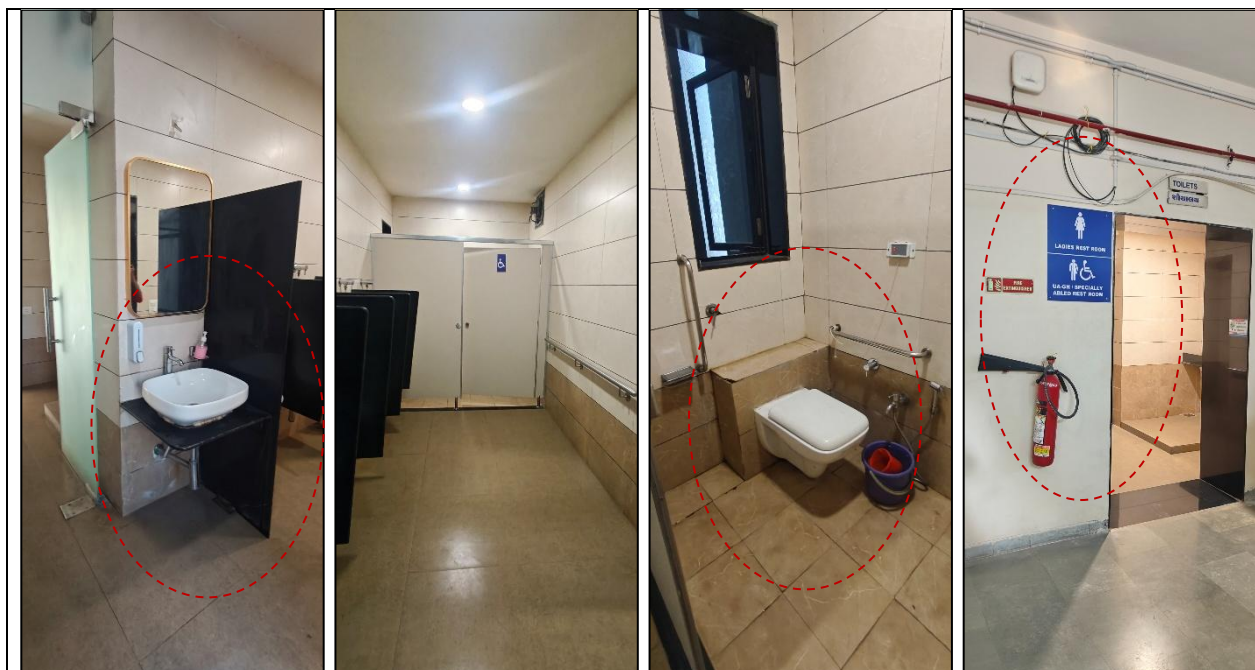
- A wheelchair-accessible doorway with adequate manoeuvring space outside the toilet
- A minimum clear internal manoeuvring space of 1500 mm × 1500 mm
- Adequate clear space adjacent to the WC to allow wheelchair transfer
- Properly positioned and compliant grab bars to support safe transfer to and from the WC

Based on the above observations, these essential provisions are not fully satisfied in the inspected restroom facilities.

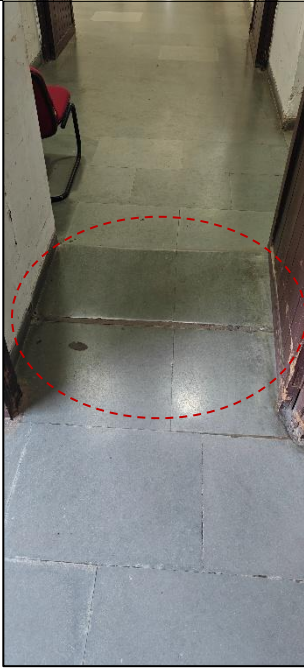
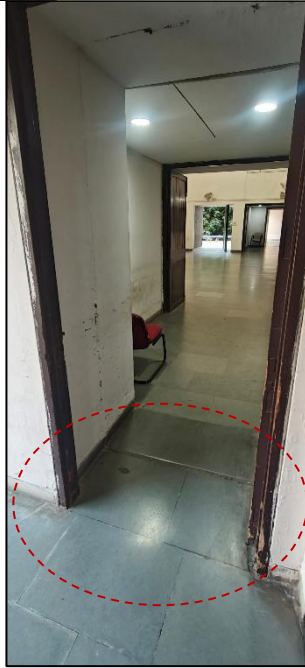
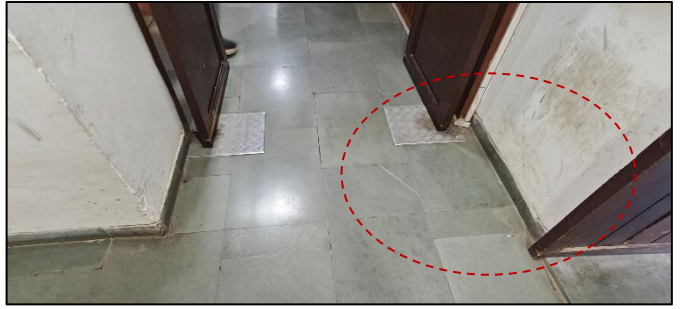
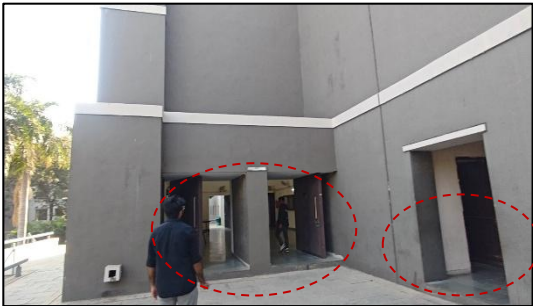
| <p><b>The Honourable Chief Justice's Court (Court No. 1) :</b> Access to the premises of Court No. 1 is restricted; therefore, the following observations are based on notes recorded during the site visit.</p> <p><b>Lobby and External Access:</b></p> <p>A lobby area is provided outside the courtroom, forming part of the peripheral corridor circulation that connects all courtrooms. This lobby has restricted entry through doors located along the accessible route within the corridor. The door opening width from the corridor to the lobby (outside the courtroom) does not comply with accessible standards. Additionally, a level difference of approximately 1 inch (25mm) was observed at the threshold, which presents difficulty for wheelchair users and persons using mobility aids.</p> <p>The lobby also connects to external terraces that have a level drop of approximately 7 inches (175 mm) without an accessible transition. This renders the terraces inaccessible to wheelchair users and persons with mobility impairments. As this area forms part of the accessible circulation route, tactile warning indicators are required at all changes in level to alert persons with visual impairment. No compliant tactile warning surfaces were observed.</p> <p><b>Main Courtroom Interior:</b></p> <p>The main courtroom floor slopes (steps down) downward toward the Chief Justice's platform. All audience seating is fixed. The last row of seating near the main public entrance provides partial practical accessibility for wheelchair users; however, no designated wheelchair space with a compliant clear floor area is formally provided.</p> <p>A wooden beading strip securing the carpet at floor level creates an additional barrier for wheelchair movement. The stepped configuration of the courtroom prevents wheelchair access to the lower audience rows.</p> <p><b>Continuous steps are provided on both sides of the courtroom, leading to:</b></p> <ul style="list-style-type: none"> <li>• A first elevated platform (approximately 300 mm and above) designated for lawyers.</li> <li>• A second elevated platform accessed by additional steps for the workstations of the Court Master/Reader, Stenographer, and Bench Clerk.</li> </ul> <p>Neither the lawyers' area nor the court staff workstations are accessible to persons with mobility impairments. There is no ramp, lift, or alternative accessible means of reaching these platforms. Wheelchair users cannot access the stepped audience seating, the lawyers' work area, or the court support staff area.</p> <p>The side passageways are partially encroached upon by book racks, reducing the effective width and compromising clear circulation space. This condition may also affect safe emergency egress.</p> <p>The stepped layout and absence of compliant handrails on both sides of the passageways present significant barriers not only for persons with mobility and ambulatory impairments, but also for persons with visual impairment, low vision, elderly users, and others requiring support (hand rail) for safe movement.</p> <p>Accessibility requirements for the judges' chambers and internal judicial access areas were outside the scope of this audit.</p> | | | | |

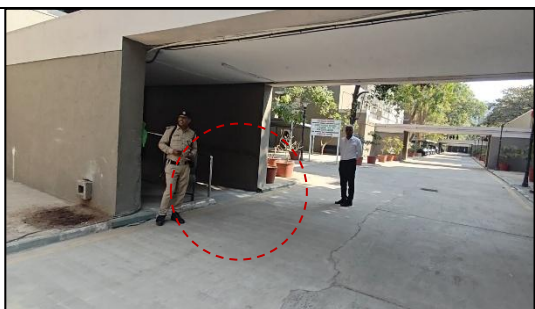
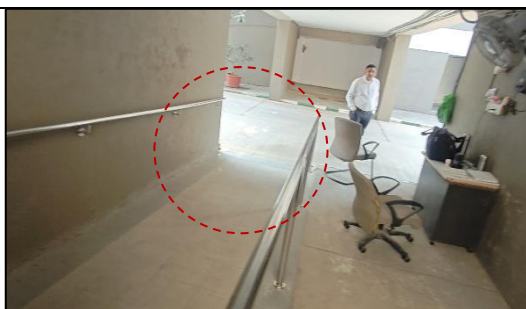
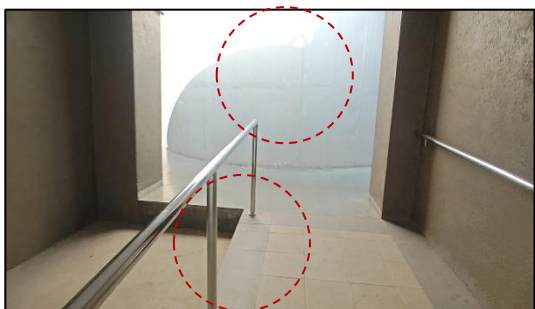
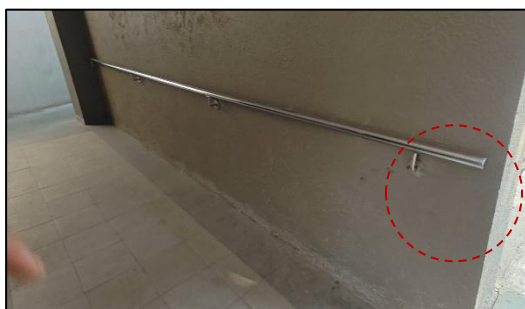
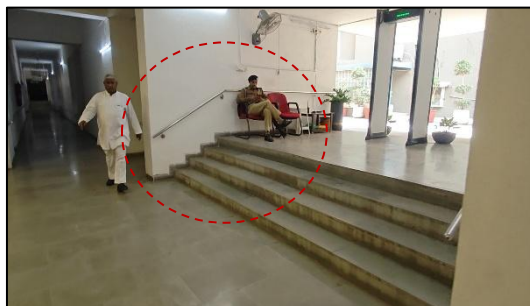
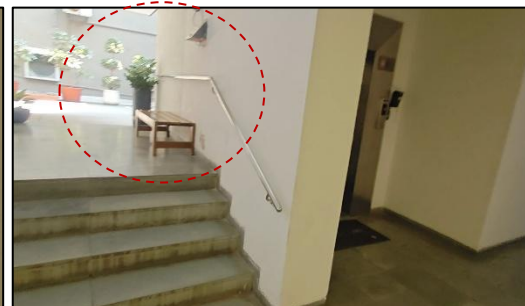
Tactile warning indicators at the top and bottom of the stairs were not observed. Visual contrast at stair nosings was not evident.

**South (Informal) Entry:** No entrance steps are provided at this entry; access is via ramp.

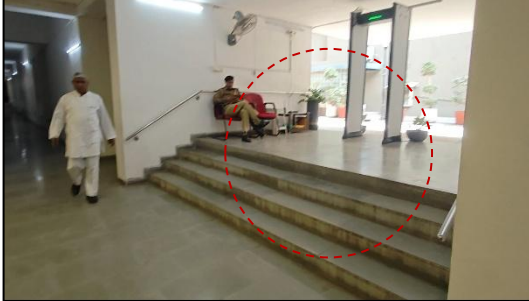
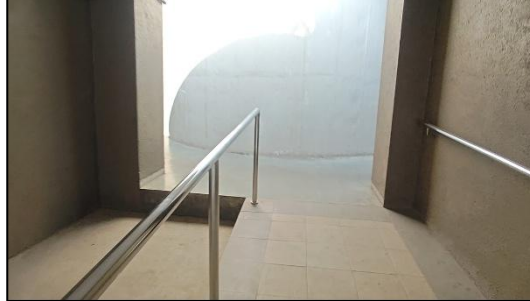
**North (Formal) Entry:** At the north formal entry, there are no entrance doors installed to secure or control direct access into the building. Entry from the driveway leads directly into the lobby area without a door threshold or controlled door system. This entry connects directly to the central corridor spine at ground floor level.

**South (Informal) Entry:** At the south informal entry, there are also no entrance doors provided at the building line. The ramped approach leads into an open passageway without a lockable or controlled door system. This passageway connects directly to the central corridor spine at ground floor level.

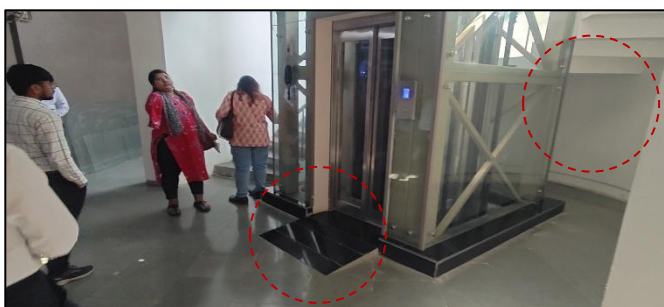
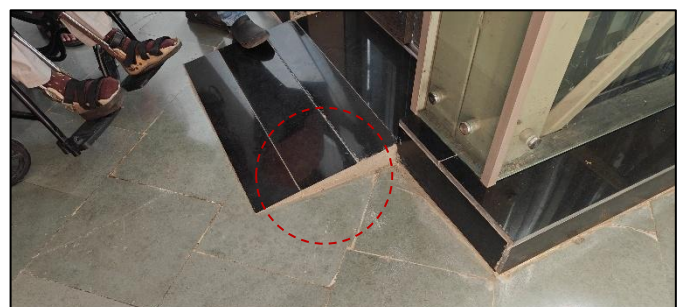
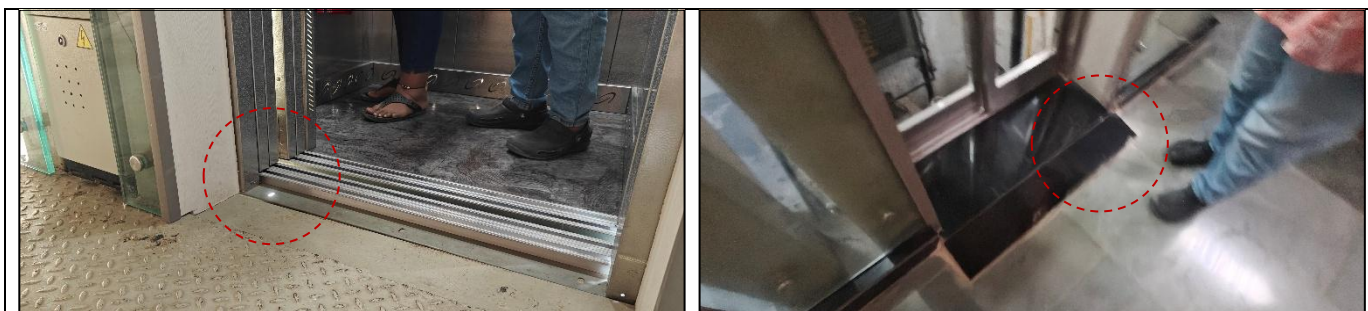
There are two newly retrofitted elevators located at the north and south ends of the building, inserted within the existing helical staircase space. Both landing areas are raised by approximately 2–5 inches and require a small added ramp finished with glossy granite strips. During simulation, this surface was found to be extremely difficult for persons with low vision and for users on crutches. The ramp also protrudes into the movement area, creating access difficulty.

Buttons comply in height (approx. 1200 mm) and are tactile. Door shutter width is approximately 850 mm; however, effective usability is affected by the non-compliant ramp condition at the landing. Overall, wheelchair users will not be able to use these elevators independently.

The central elevator, located within the earlier building core, also does not comply with accessibility guidelines. There is no tactile signage or directional indicators. The threshold measures approximately 35 mm and is not bevelled. Loose floor mats (approximately 9-foot length) are placed at the entrance and act as barriers for persons with mobility impairment, users on crutches, and persons with visual impairment.

The clear door opening was found to be between 790 mm, as the door does not open fully, the clear space was reduced to 700 mm. This does not meet minimum width requirements. Internal car space is significantly smaller than the required standards and does not allow wheelchair manoeuvring.

The control console height is approximately 1200 mm, and the emergency device is positioned at approximately 1500 mm height. While persons using crutches or with other mobility limitations may access the elevator with difficulty, wheelchair users will face major constraints.

All three elevators — north, south, and central — do not comply with the accessibility guidelines required for independent wheelchair use.

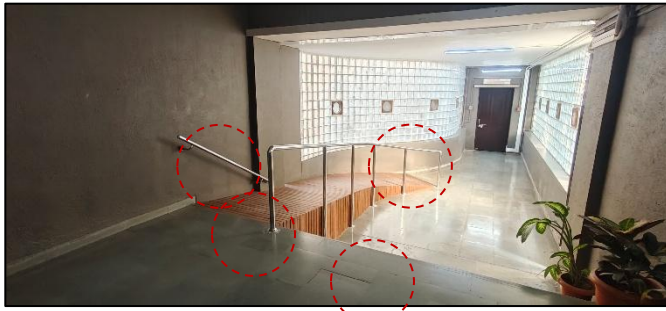
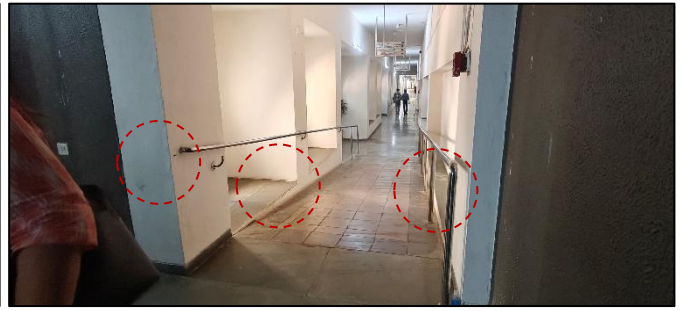
**Ground Floor – North Ramp (Specific Issues):** The north ramp has similar issues with top and bottom landings. This ramp does not have a wall on both sides throughout its length, and the railing does not have a bottom rail (minimum 75 mm curb). This is a hazard for wheelchair users, as there is no protective edge to prevent the front wheel from slipping off. The railing also does not extend out at both top and bottom landings. At one end handrail do collide with electrical socket and can be issue with person with vision impairment manoeuvring using it.

The adjacent steps do not have handrails on both sides. There are no tactile tiles provided for either the steps or the ramp. Tactile warning tiles at both top and bottom of this ramp are also missing.

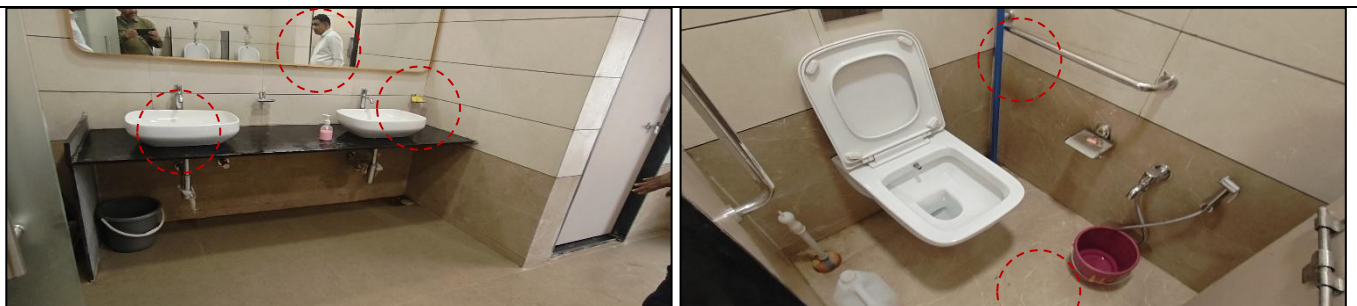
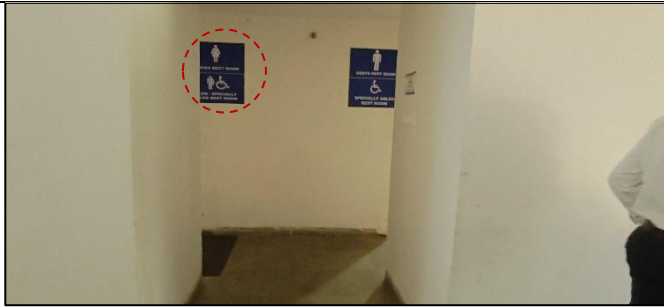
**North Side Restrooms:** The north side restrooms, located adjacent to the pantry area, have similar layout and dimensional issues and are not accessible. Manoeuvring space is inadequate for wheelchair users. Door thresholds, stall dimensions, and grab bar provisions do not comply with accessibility requirements. Signage and wayfinding provisions are also inadequate.

Based on the above observations, these essential provisions are not fully satisfied in the inspected restroom facilities.

- A wheelchair-accessible doorway with adequate manoeuvring space outside the toilet
- A minimum clear internal manoeuvring space of 1500 mm × 1500 mm
- Adequate clear space adjacent to the WC to allow wheelchair transfer
- Properly positioned and compliant grab bars to support safe transfer to and from the WC

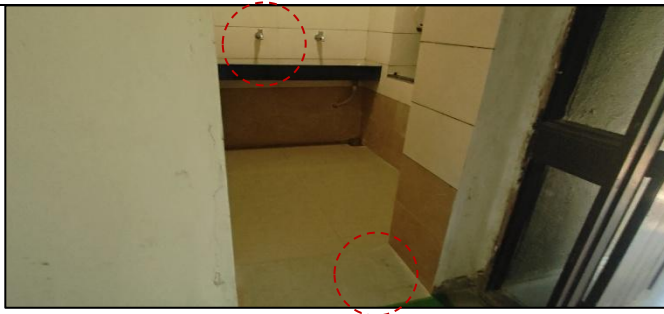
At the south side, no signage with tactile indication is provided for the drinking water point. The drinking water cooler and taps are wall-mounted, and the tap height is too high to be conveniently used by a person on a wheelchair. While the frontal opening width allows approach, there is insufficient space to return or perform a 360-degree turning movement, making the area difficult to manoeuvre. The configuration does not comply with HGSUAI-2021 accessibility standards.

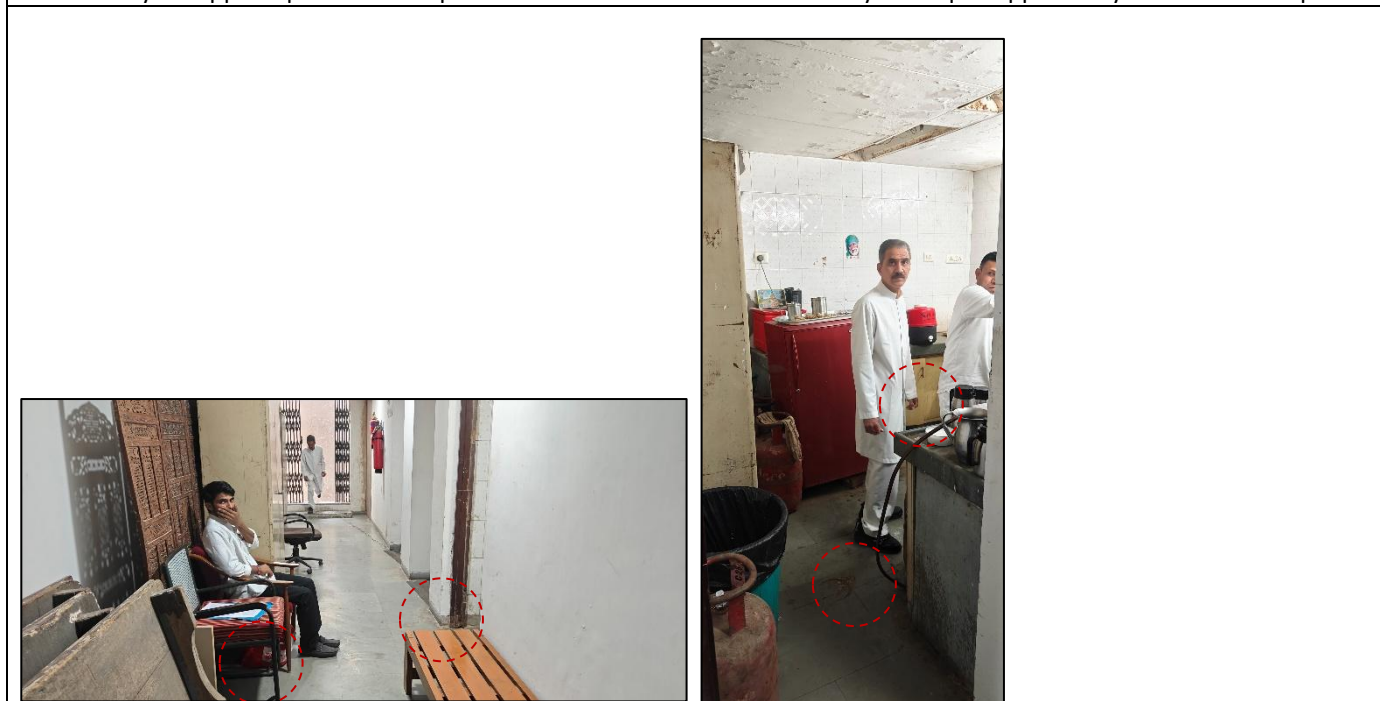
The pantry for support staff is located on the north side of the building at the ground floor, near the elevator lobby. The passageway leading to the pantry is encroached by storage, and access to the pantry door is possible only through a tight manoeuvring turn. Inside, the pantry is heavily occupied with storage items and gas cylinders, which does not allow any accessible manoeuvring space.

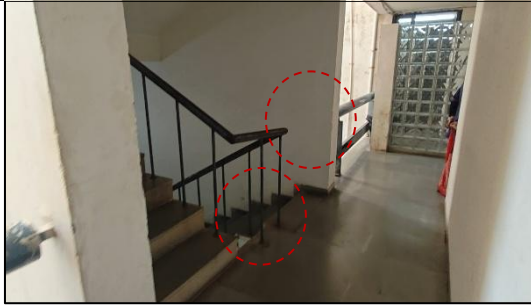
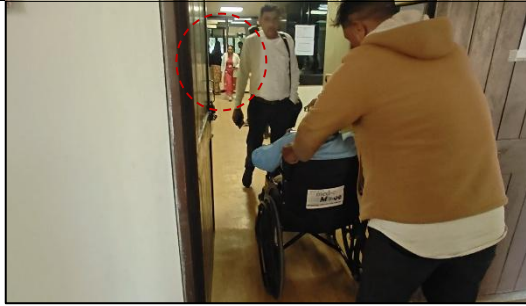
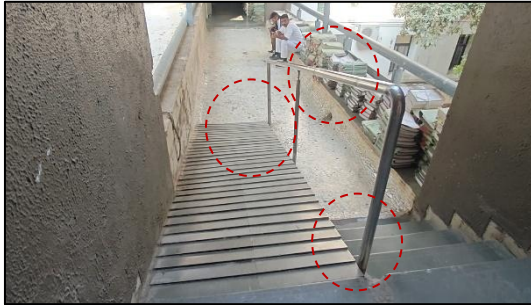
No tactile guide tiles or warning tactile tiles were observed in circulation areas. There are no clear signboards for wayfinding, accessibility identification, or emergency fire egress.

The Computer Centre facility in Block 24 is highly inaccessible in its present condition. The absence of an elevator, non-compliant ramps, non-compliant staircase dimensions, inaccessible restrooms, and lack of tactile and signage provisions collectively result in significant barriers for persons with disabilities, including wheelchair users and persons with ambulatory impairments. Retrofit interventions would be required to achieve compliance with accessibility guidelines.

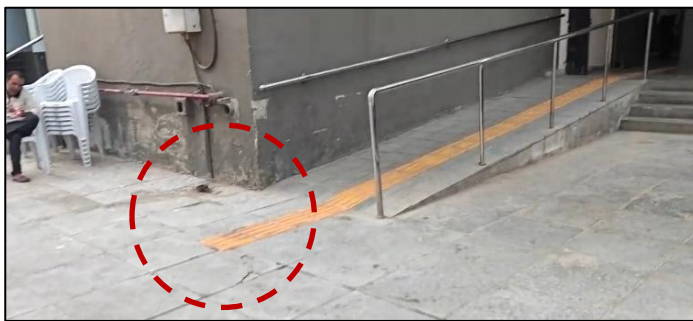
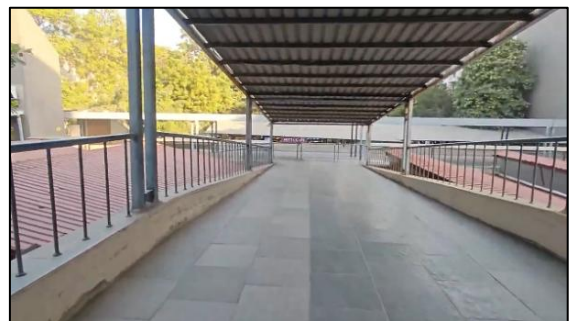
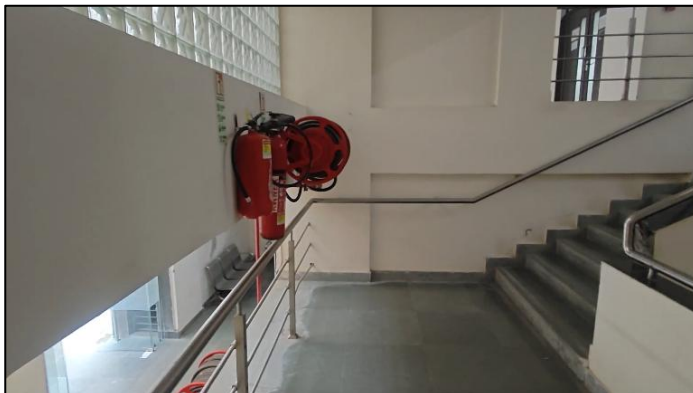
1.5 Alternative Vertical Access: Access to the first-floor courtrooms is provided through a accessible elevator. The staircases are not barrier-free, as fire extinguishers are placed on the landings, obstructing the clear width and circulation space.

1.6 Entrance steps: The steps are not provided with tactile indicators.

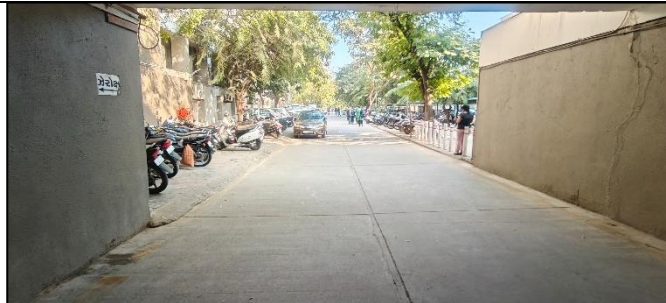
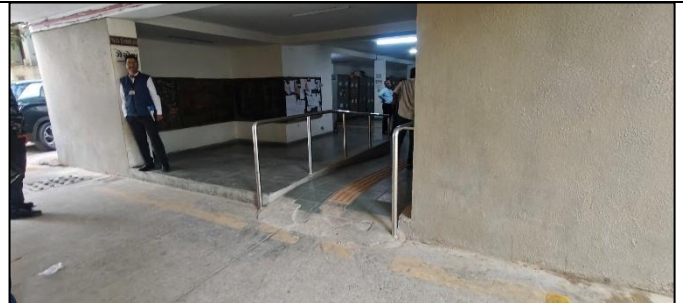
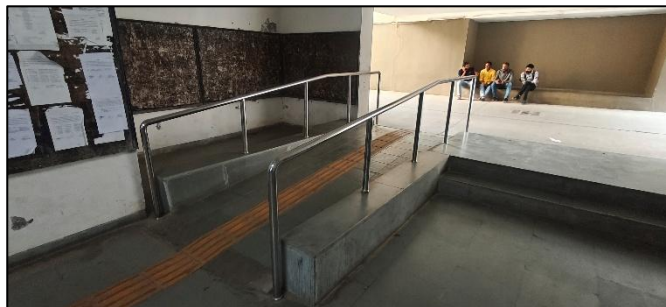
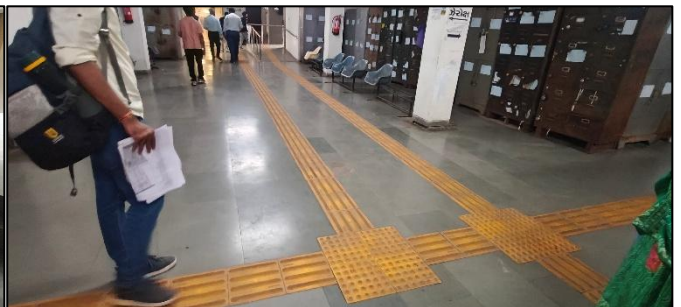
The ramp provides access only to the ground floor of Wing A, Wing B, and the staff canteen.

**1.5 Alternative Vertical Access:** Access to the first floor and the covered corridor connecting to the Main Court Building (Buildings 14–18) is provided only through staircases and elevators located in Wing A and Wing B. Vertical circulation is reviewed in detail under Sections A-6.00 and A-7.00.
