# Accessibility Audit Checklist for Built Environment

- **Name of Project / Facility:** Gujarat High Court – Government Complex
- **Location:** Sola, Ahmedabad- 380060, Gujarat
- **Type of Facility:** Institutional Complex
- **Date(s) of Audit performed on site:**
  - Saturday, 20/12/2025 | Sunday, 21/12/25
  - Monday, 19/01/26
- **Date of Audit report generated:**
  - Revision - 00 : March 02, 2026

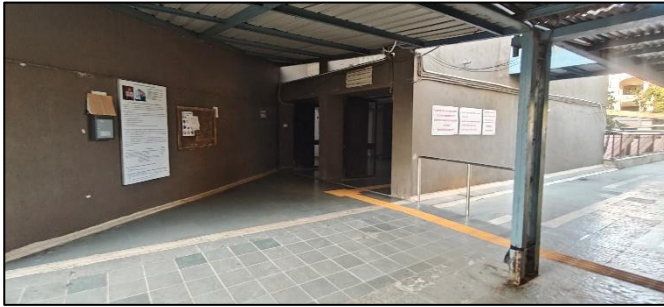
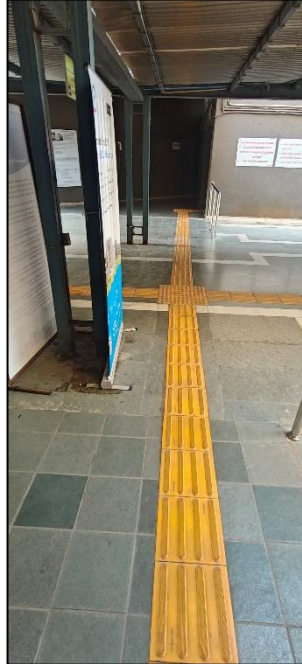
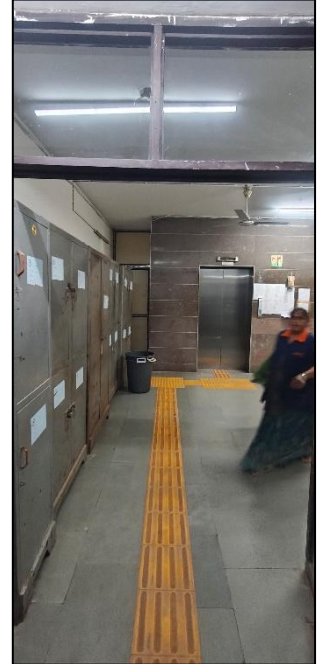
Door swings are clear of major circulation routes and do not obstruct accessible movement. Doors typically remain in the open position during working hours, allowing unobstructed circulation.

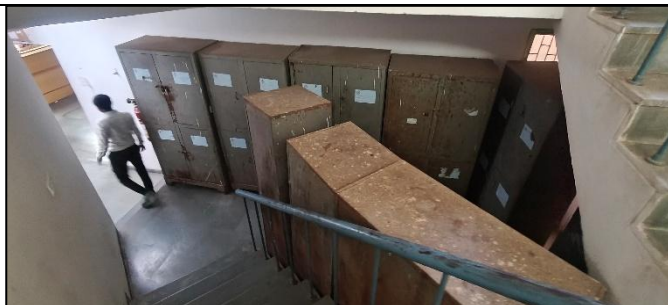
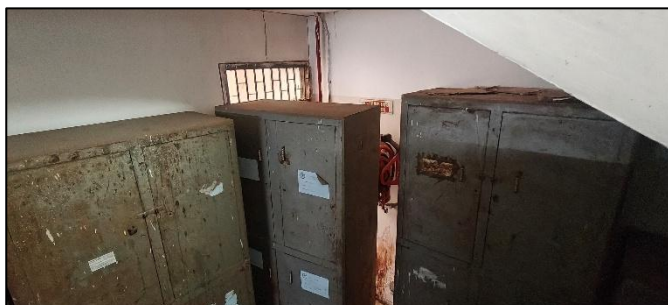
Inadequately placed storage cabinets obstruct access to fire safety equipment, including fire extinguishers and hose reels. These obstructions reduce the required clear space around the equipment and may delay response time during an emergency.

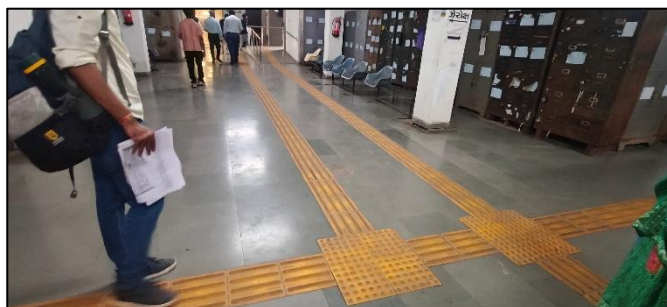
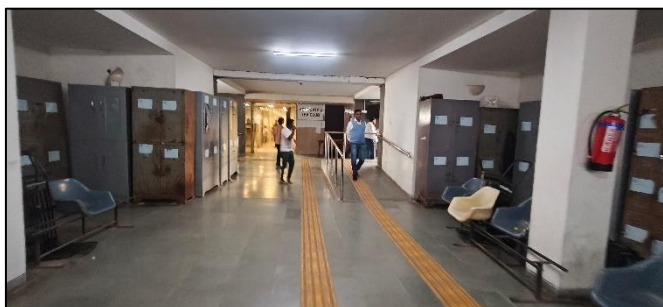
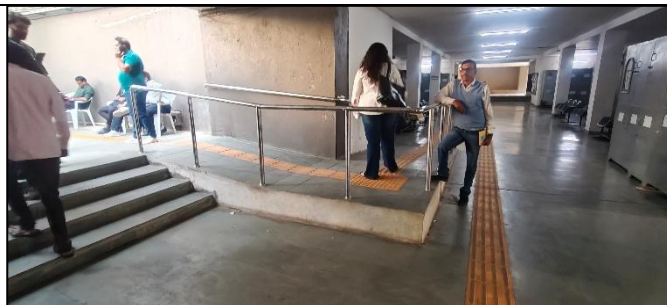
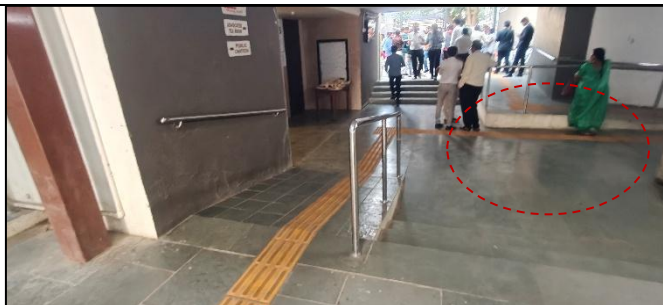
In addition, tactile paths should be supported by orientation aids such as tactile maps or information panels at major entry and decision points. Currently, no tactile site maps or orientation maps are provided at the main entrance or lobby areas. Without these supporting elements, the tactile paving functions only as a directional strip and does not provide meaningful navigational information.

Installation of tactile orientation maps at primary entry points and key junctions is strongly recommended to enable safe, intuitive, and independent wayfinding within the building complex.

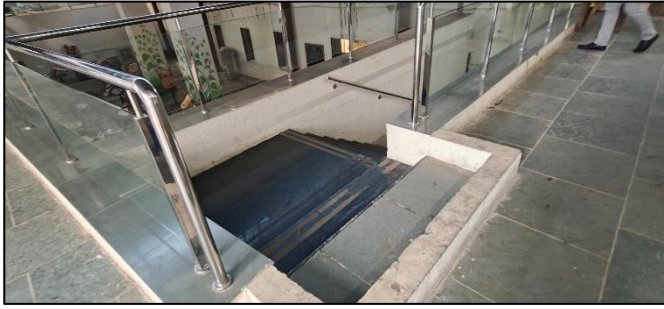
| <b>Canteen (28):</b><br>The assessment of the primary access to the Public Canteen (basement). Access to these areas is from the ground floor level through the main hallway in Advocate Building “A” Wing and “B” Wing. Access to the Advocate Canteen (located below the corridor) was restricted; therefore, it has not been included in this assessment.<br><br>The basement canteen is not accessible and cannot be considered barrier-free. Access is provided only via a staircase from the ground floor level. The staircase is obstructed at the ground floor, and no clear landing space is provided. As per accessibility codes, stairs should not open directly into a circulation area without an adequate landing. The absence of a defined landing compromises safe movement and maneuverability. No alternative accessible route, such as a ramp or elevator, is provided to access the basement canteen. As a result, persons with mobility impairments are unable to access this facility independently.<br><br>The staircase also does not comply with accessibility requirements in terms of tactile guidance. Tactile indicators are not provided at the start and end of the staircase to assist persons with visual impairments. Additionally, no signage is installed to support wayfinding or to indicate the location and access conditions of the canteen. | | | | |

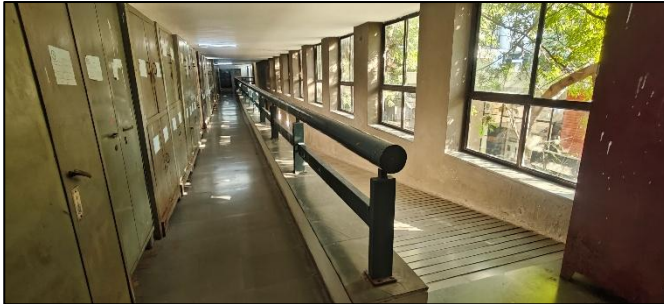
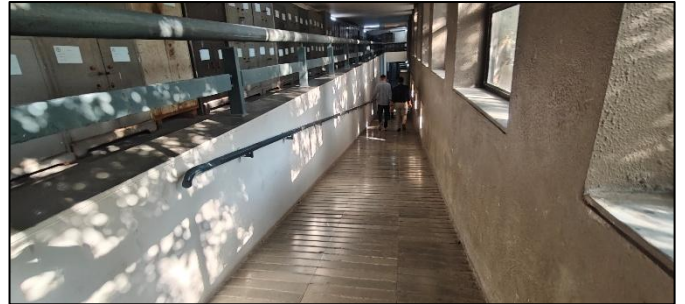
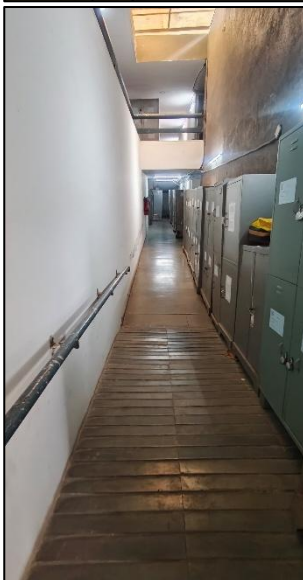
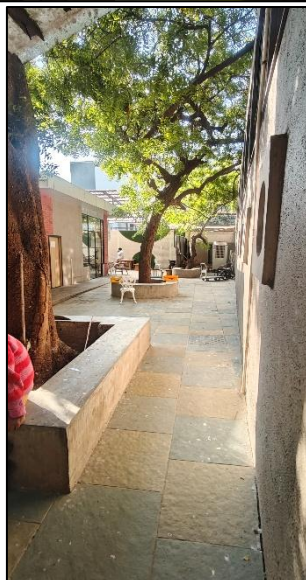
## 16.00 Access to the Bar room (25)

The assessment of the primary access to the Bar Room first floor is provided. Access to other floors and workspaces was restricted and could not be assessed. The ramp connecting the south-side first-floor corridor to the ground floor open space around the café was assessed, as it serves as the primary access route from the first-floor corridor to the ground floor, café, and Bar Room.

The ramp slope complies with the applicable accessibility standards. However, the total ramp length is approximately 15 meters and no intermediate landing is provided. As per accessibility guidelines, intermediate landings are required at specified intervals to allow users to rest, reposition, and safely control movement. The absence of intermediate landings makes the ramp difficult to use independently, particularly for wheelchair users, who may require external assistance to ascend or descend safely.

In addition, the passage along the ramp is partially obstructed by storage racks and furniture items, which reduce the effective clear width. This further restricts maneuverability and does not comply with the minimum clear width requirements for accessible routes.

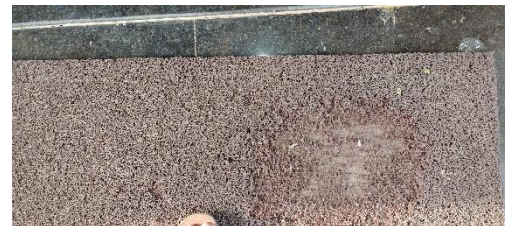
### 4. Entrance and Floor Levels

The doormat at the entrance is difficult to maneuver across, especially for wheelchair users. Additionally, there are level differences in multiple areas of the building, creating accessibility barriers and disrupting smooth movement.
